**AIRPROX REPORT No 2015130**

Date: 6 Aug 2015 Time: 1308Z Position: 5119N 00001E Location: Biggin Hill Airport

**PART A: SUMMARY OF INFORMATION REPORTED TO UKAB**

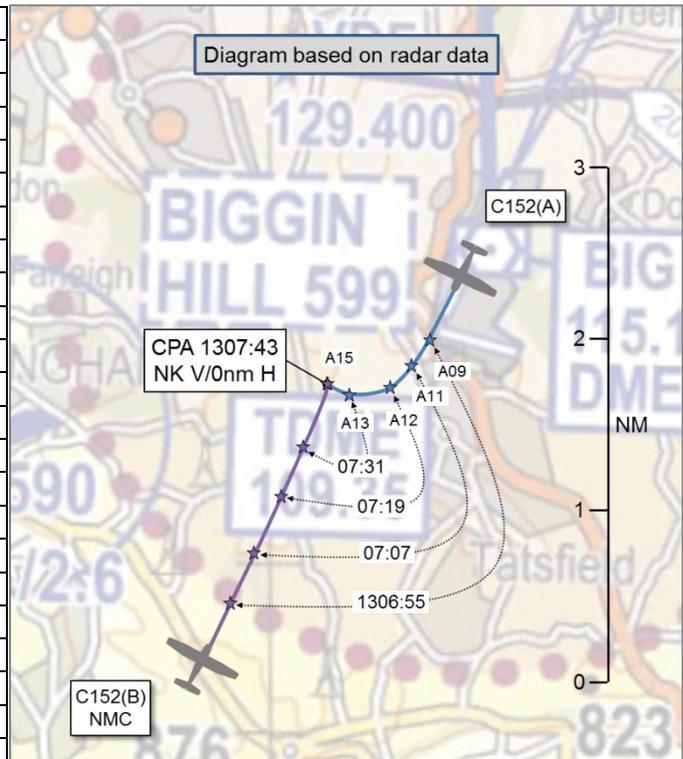
**THE CESSNA 152(A) PILOT** reports that he was carrying out a circuit training detail on RW21RH in preparation for his student’s first solo. They heard the C152 (B) pilot, who was routing inbound from the west, being instructed to call at 5nm. On one of the touch-and-go landings, ATC asked them to initially maintain runway heading after take-off. On hearing a slightly unclear call thought to be directed to them, he asked if they could commence the turn onto the crosswind leg. They were instructed to do so, and were advised they would be number one. They were aware of, and heard, the other pilot being told to join downwind number two to a C152 currently on the crosswind leg (his aircraft). The other pilot acknowledged the instruction and, he believed, confirmed having his aircraft in sight. His student levelled out at 1000ft on the crosswind leg, and started the look-out prior to commencing the right turn onto the downwind leg. They had looked to the left and saw nothing, and were just scanning round from left to right prior to the turn when the aircraft crossed ahead of them. The C152 had suddenly appeared above their port wing, descending approximately 30-50ft ahead of their windscreen (crossing from their 8 to 12 o’clock), and then descended further into a low downwind leg position ahead of them.

The Board noted that the 2 aircraft had been very close to each other at the time of the Airprox. Radar recordings showed that they were less than 0.1nm apart horizontally, although it was not possible to positively determine the vertical separation because C152 (B) was not equipped with SSR Mode C. However, the Board noted that the C152 (A) pilot had reported a vertical separation of 30-50ft as C152 (B) descended across their path; the Board also noted that C152 (B) pilot had not seen C152 (A) at all. Accordingly, the Board quickly decided that separation had been reduced to the minimum and, because neither pilot had effectively seen the other before CPA, luck had played a major part in the incident. Consequently, the Board decided that the Airprox should be categorised as risk Category A.
