AIRPROX REPORT No 2015205

Date: 23 Nov 2015 Time: 1414Z Position: 5114N 00135W Location: 7nm NE Boscombe Down

PART A: SUMMARY OF INFORMATION REPORTED TO UKAB

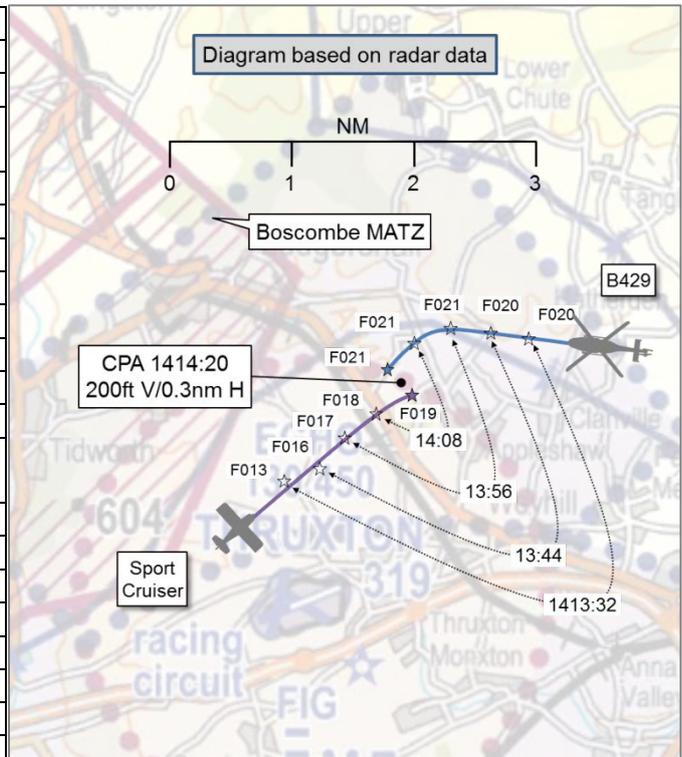
THE BOSCOMBE DOWN DIRECTOR reports that he was working one aircraft on VHF, a Bell 429 (B429) on a Traffic Service, whose pilot had requested instrument approaches to Boscombe Down. The B429 pilot was descended to 2000ft on the QFE 1010hPa and fed in from the south of the Boscombe centre-line. At a suitable time, he turned the B429 pilot onto a heading of 270° and asked him to report localiser established. During this time there was pop-up traffic within the Thruxton ATZ with a squawk of 7000, indicating 1200ft below the B429. He called it to the B429 pilot as 'pop-up traffic south-west, 3 miles, manoeuvring, indicating 1200ft below, climbing, could be outbound from Thruxton'. Just north of Thruxton the aircraft turned onto a north-easterly heading appearing to fly up the approach-lane towards the B429 and continued to climb. He informed the B429 pilot that the traffic was in his 'left, 10 o'clock, 1 mile, crossing left-right behind indicating 300' below climbing, if not sighted continue present heading'. At this time the B429 pilot reported visual. The unverified aircraft continued to climb against the B429 slightly south of the centre-line and stopped climb approximately 9nm from Boscombe on the approach-lane, clear of the B429, with a Mode C indication of 2100ft.

intercept the ILS to avoid the conflicting traffic. The other aircraft flew just down the B429's left, indicating vertical separation of 150-200ft on Mode C and still appeared to be climbing. When clear of the conflicting traffic the B429 pilot continued his approach and the pilot of the other aircraft appeared to level off at 2000ft transiting to the northeast, never calling Boscombe LARS. He spoke to Thrupton and they passed him details of the aircraft [the Sportcruiser]. They also informed him that the pilot had been informed that Boscombe was open. He reported that when talking later to the Sportcruiser pilot he had said that he was unfamiliar with the standard procedure for departing out of Thrupton. He did inform him that he had been visual with two helicopters, and that he had stopped off clear of the one close to him. He was unaware that the B429 would have shortly started descent against him, and that they had avoided his profile out of Thrupton.
