**AIRPROX REPORT No 2015004**

Date: 22 Jan 2015 Time: 1703Z Position: 5610N 00101W Location: D613C  
(Twilight)

**PART A: SUMMARY OF INFORMATION REPORTED TO UKAB**

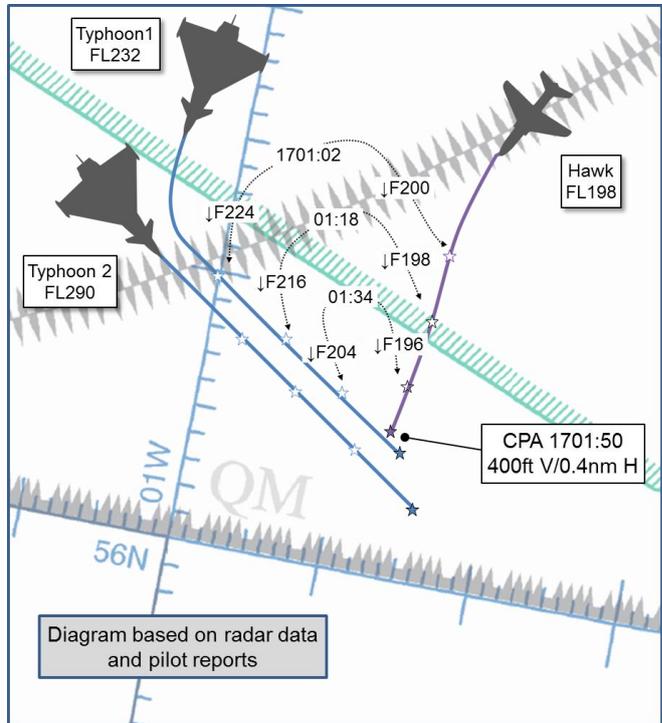
Recorded	Aircraft 1	Aircraft 2
Aircraft	Hawk T1	Typhoon FGR4
Operator	HQ Air (Ops)	HQ Air (Ops)
Airspace	Scottish FIR	Scottish FIR
Class	G	C
Rules	IFR	IFR
Service	Traffic	Traffic
Altitude/FL	FL194	FL198
ACAS/TAS	Not fitted	Not fitted
Transponder	A, C, S	A, C, S
<b>Reported</b>		
Colour	Black	Grey
Lighting	Navigation, red HISL, Nose light	Navigation, red HISL
Conditions	VMC	VMC
Visibility	100km	30km
Altitude/FL	FL190	FL200
Speed	180kt	300kt
<b>Separation</b>		
Reported	300ftV 800ft H	'400ft'
Recorded	400ft V/0.4nm H
