AIRPROX REPORT No 2015066

Date: 11 May 2015 Time: 0819Z Position: 5202N 00022W Location: Nr Ledbury

PART A: SUMMARY OF INFORMATION REPORTED TO UKAB

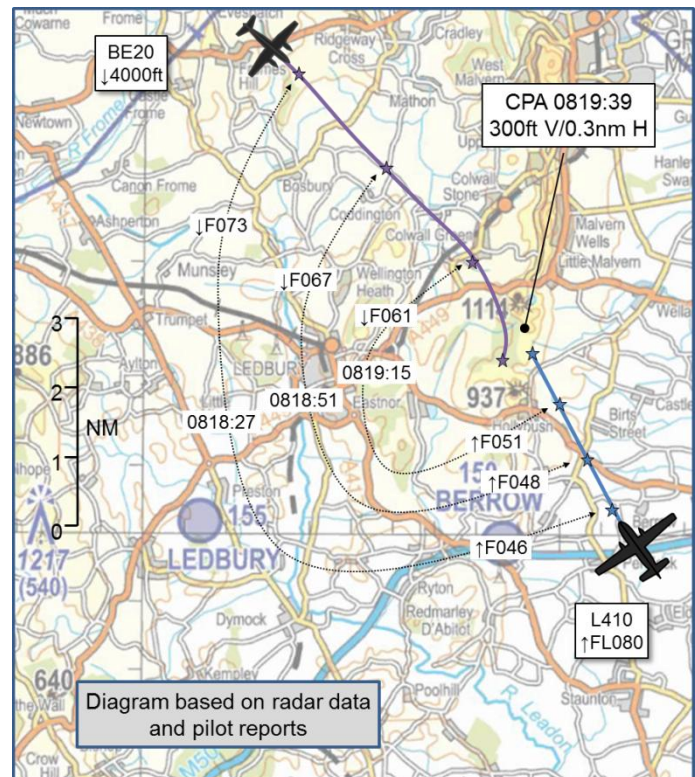
THE L410 PILOT reports climbing out from Gloucestershire airport, IMC passing FL50, when the controller passed Traffic Information on opposite direction VFR traffic. He received a TCAS RA to stop climb and initiate descent, which he followed. At the nearest point, the TCAS indicated the other traffic 200ft overhead but, being IMC, the pilot did not see it.

At 0819:39, CPA occurred (0.3nm and 300ft) as the BE20 had turned to the right (Figure 3). The L410 had stopped the climb and descended to 5200ft – the climb rate indicated the L410 had levelled off.
