AIRPROX REPORT No 2015072

Date: 26 May 2015 Time: 0927Z Position: 5236N 00028E Location: 6nm SW Marham

PART A: SUMMARY OF INFORMATION REPORTED TO UKAB

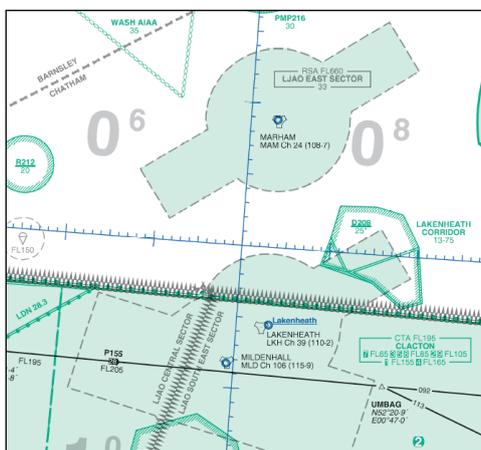
Figure 6: Positions of Marham and Lakenheath MATZs.

The relative positions of the RAF Marham and RAF Lakenheath MATZs are at Figure 6, both with runway configuration of 06/24.
