AIRPROX REPORT No 2015085

Date: 18 Jun 2015 Time: 1016Z Position: 5140N 00210W Location: Gloucester Airport (101ft)

PART A: SUMMARY OF INFORMATION REPORTED TO UKAB

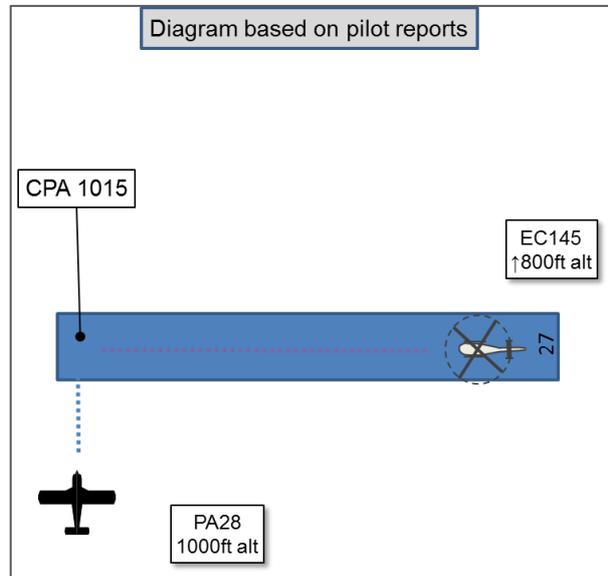
THE EC145 PILOT reports undertaking an IFR go-around climb in VMC, with the student simulating IMC from a missed approach to the ILS RW27 at Gloucester. At about 800ft, the instructor had to take control of the aircraft and take avoiding action to miss a small fixed-wing aircraft which was crossing the runway centreline close to the RW09 threshold at approximately 800-1000ft. The instructor descended to 500ft and turned left slightly to avoid, before returning control of the aircraft to the student to climb back on runway heading. ATC's initial clearance for the go-around was straight ahead to 4000ft, this was changed during the initial go-around climb to turn onto heading 350° with no mention of the conflicting traffic. The fixed-wing pilot appeared to be doing a 'dead-side' join procedure, crossing from south to north to join the crosswind section of the RW27 right hand circuit.

He assessed the risk of collision as 'High'.
