AIRPROX REPORT No 2015101

Date: 2 Jul 2015 Time: 1407Z Position: 5300N 00037W Location: 5nm SW Cranwell

PART A: SUMMARY OF INFORMATION REPORTED TO UKAB

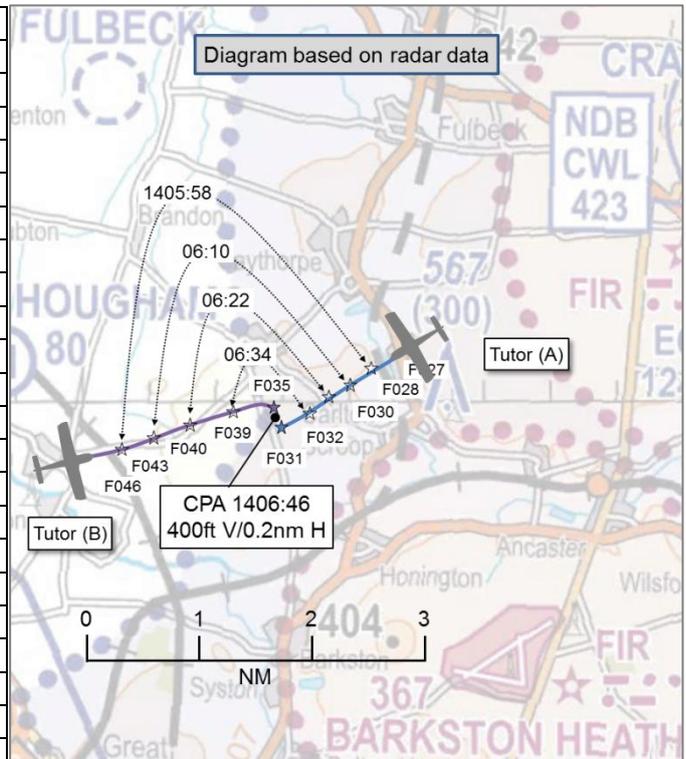
THE TUTOR(A) PILOT reports conducting a training flight. The student departed on a SID and was in the climb to 5000ft. Passing 2000ft, on a south-westerly heading, they heard another Tutor being passed Traffic Information on their location. At 2500ft they were told of its location and the instructor directed the student to level the aircraft at 3000ft, to allow 1000ft separation. Shortly after this they were told the other Tutor was at a range of 2nm, in the 12 o'clock, 1000ft above. The TAS showed the other Tutor still descending and closing inside 1nm, at which point the TAS gave a Traffic Alert. The instructor became visual with the other Tutor in a descending turn, pointing towards his aircraft, with the TAS showing 300ft separation. He took control and maintained heading until he was sure of the other pilot's intentions so that he could take appropriate action to avoid any collision. As the TAS read 200ft, the other Tutor turned away and continued with Cranwell Tower.

THE TUTOR(B) PILOT reports conducting an Air Experience Flight, returning to base from the west-southwest. He received information on a similar type departing from the airfield which was already showing on TAS and was discussed with the Air Cadet passenger. The aircraft was immediately visually identified in the climb at a range of about 3nm, to the right of the nose, separated horizontally, with more than 1000ft separation. Because he was visual, TAS had alerted and he had Traffic Information on the other aircraft, he continued the descent, maintaining lateral separation of not less than 0.5nm at all times. As they passed abeam, separated vertically by some 300-400ft, he turned through 90° in order to 'show the other Tutor to the passenger'. The nose of his aircraft remained behind the other Tutor at all times and they continued to diverge. The pilot noted to the passenger that although there was a 'big sky', look-out and use of TAS were essential in maintaining SA and separation. He stated that no Airprox had occurred because he was visual with the other aircraft.

Both Tutor pilots shared an equal responsibility for collision avoidance and not to operate in such proximity to other aircraft as to create a collision hazard¹. If the incident geometry is considered as head-on or nearly so then both pilots were required to turn to the right², notwithstanding their responsibility for collision avoidance. The CPA was assessed as 400ft vertically and 0.2nm horizontally from area radar recordings made available to UKAB.
