## IRPROX REPORT No 2015124

Date: 3 Aug 2015 Time: 1532Z Position: 5343N 00235W Location: 10nm ESE Warton

### PART A: SUMMARY OF INFORMATION REPORTED TO UKAB

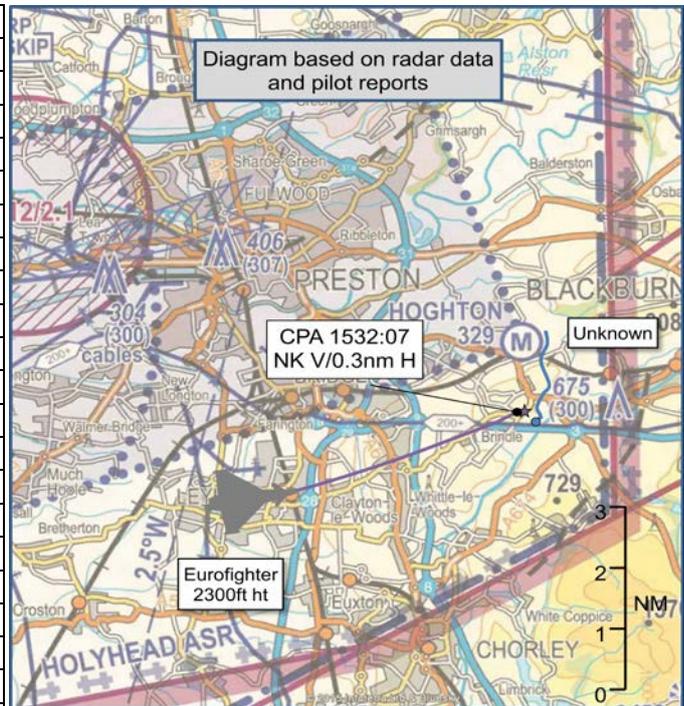
**THE TYPHOON PILOT** reports that whilst heading 070°, at 2300ft, in the radar pattern for an SRA, a light aircraft with red/white markings was observed to pass directly across his flight path approximately half a mile ahead and 200ft above. This occurred at the same time as the call to turn crosswind from ATC, he assessed there was no risk of collision due to the turn; however, separation appeared compromised. ATC reported that they had no traffic in the vicinity.

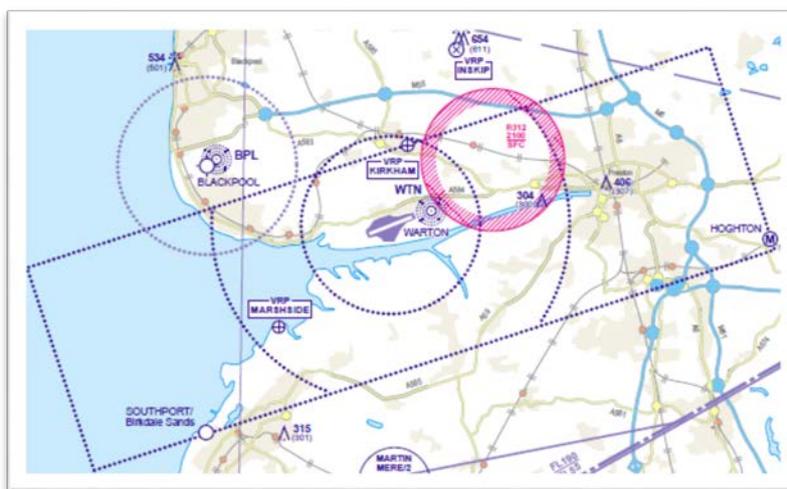
Figure 1: Warton MATZ - AIP

The Typhoon, under a Traffic Service, was being radar vectored around the radar circuit at Warton towards a Surveillance Radar Approach for Runway 25. In addition to the ATZ at Warton there is also a non-standard MATZ extending 10nm to the east and west of Warton - although this remains Class G airspace.(Figure 1)
