AIRPROX REPORT No 2015131

Date: 31 Jul 2015 Time: 1020Z Position: 5145N 00111W Location: Oxford

PART A: SUMMARY OF INFORMATION REPORTED TO UKAB

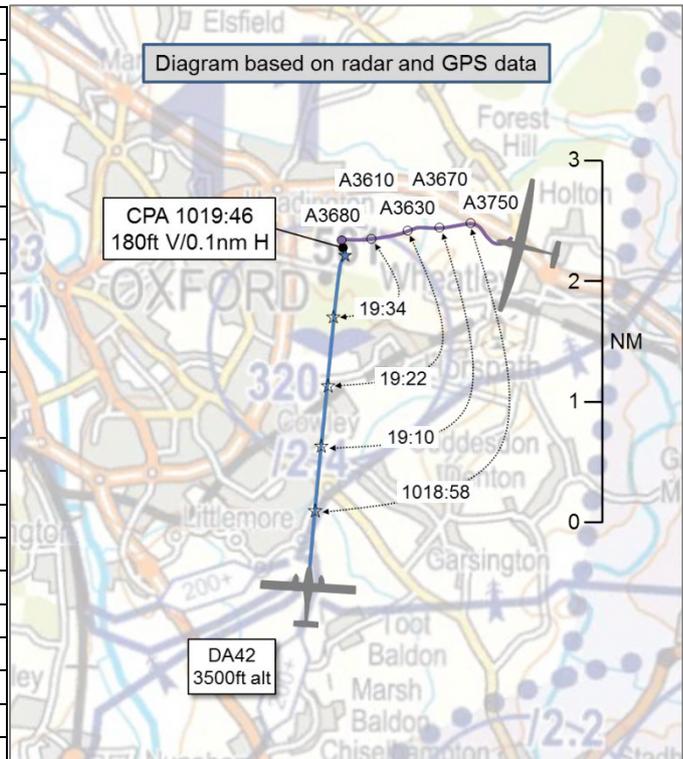
THE DA42 PILOT reports conducting a transit flight with the FO as PF, on a sunny day with FEW-SCT cloud overhead. The crew made late visual contact with a glider, ¼ mile ahead in the left 1030 position, converging from the left, slightly high and in straight-and-level flight. In the little time remaining, the PF made an avoiding-action descending right-turn as the glider effectively passed 250ft overhead. Benson made contact stating that Bicester was active and the crew replied, with information confirming such. The pilot noted that the aircraft would not have actually collided unless either aircraft had deviated from their flight-paths.

Cause: A late sighting by the DA42 pilot and a non-sighting by the glider pilot.
