AIRPROX REPORT No 2015175

Date: 2 Oct 2015 Time: 1055Z Position: 5316N 00052W Location: Headon Airfield

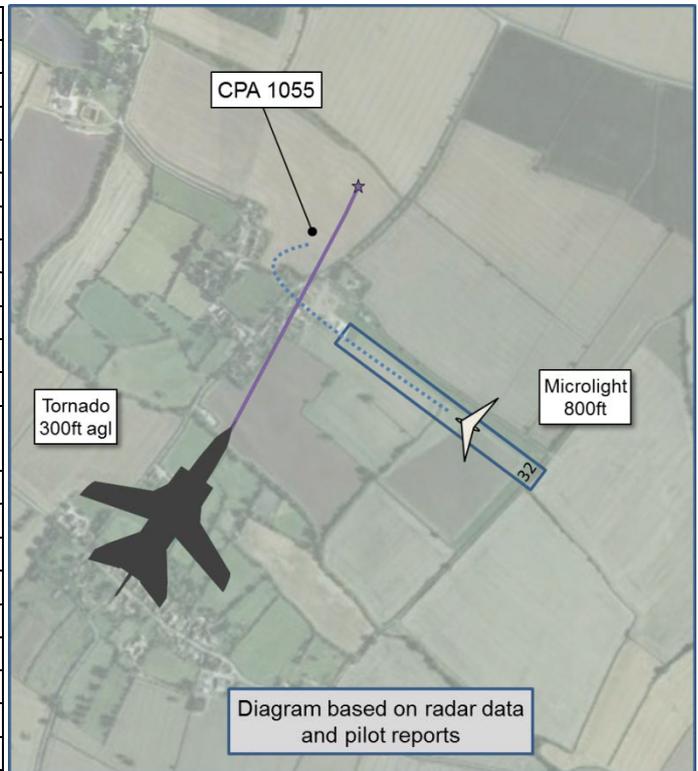
THE MICROLIGHT PILOT reports that whilst turning right to position downwind for RW32 at Headon airfield, an RAF Tornado overflew the airfield at 500ft, passing below his aircraft and slightly to the right. There was no time to take avoiding action.

THE TORNADO PILOT reports that they were informed of the Airprox a week after the event. They did not see the microlight at the time of the incident and subsequent review of their Head Up Display (HUD) and Forward Looking Infra-Red (FLIR) did not give a ‘thermal cue’ in the HUD to the pilot. He noted that although the aircraft was fitted with TCAS, there had been no indications, the most likely reason being that the microlight was not transponder equipped.

The Radar Analysis Cell estimated that the Closest Point of Approach was at 1055:32.
