**AIRPROX REPORT No 2015196**

Date: 30 Oct 2015 Time: 0619Z Position: 5117N 00023W Location: Ockham hold

**PART A: SUMMARY OF INFORMATION REPORTED TO UKAB**

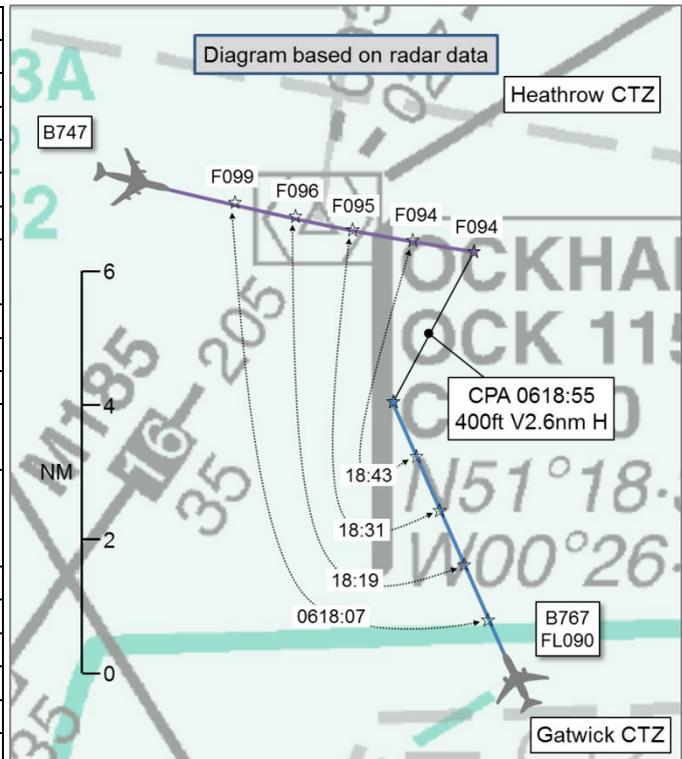
Recorded	Aircraft 1	Aircraft 2
Aircraft	B767	B747
Operator	CAT	CAT
Airspace	London TMA	London TMA
Class	A	A
Rules	IFR	IFR
Service	Radar Control	Radar Control
Provider	Heathrow Approach	Heathrow Approach
Altitude/FL	FL90	FL94
Transponder	A/C/S	A/C/S
Reported		
Colours	Company colours	Company colours
Lighting	Beacon, strobes, position, Logo, landing	NK
Conditions	IMC	IMC
Visibility	Nil	Nil
Altitude/FL	FL80	FL95
Heading	330°	090°
Speed	230kt	225kt
ACAS/TAS	TCAS II	TCAS II
Alert	TA	TA
Separation		
Reported	500ft V/2nm H	400ft V/2-3nm H
Recorded	400ft V/2.6nm H

**THE BOEING 767 PILOT** recalled that he was in the OCK hold at FL80 [UKAB Note: in fact he was at FL90]. Another aircraft joined the hold descending to the same level in front of them. He was alerted to the other aircraft on receiving a TCAS TA. He recollected that the other aircraft crossed about 2nm ahead and 500ft above after levelling at FL85. They received clearance, he thought, to expedite descent to FL70.

**THE BOEING 747 PILOT** reports that ATC cleared them to descend to FL90. On descending through FL100 and approaching the OCK hold, traffic was noted by the flight crew in the OCK hold at FL90 and converging. They levelled at ‘9500ft’ and soon after received a TCAS TA. ATC issued them with an avoiding-action heading change (he recalled heading 300° off the OCK2F SID). They complied with the avoiding-action clearance. The closest approach was estimated to be 2-3nm laterally and 400ft vertically. ATC subsequently informed them that they had been incorrectly issued a FL90 clearance by the previous sector.

**THE SWANWICK TERMINAL SOUTH CONTROLLER** reports that he was working TC South banded. The B767 was established in the OCK hold, working Heathrow INT S. He saw that the stack was laddering down, and so he re-released the B747 from FL110 to FL90<sup>1</sup>. With FL90 in his

head, he subsequently descended the B747 pilot to FL90, not realising that the level was not free in the stack. A pilot on a DVR departure then queried if he should be climbing to FL90. He realised that the pilot had taken the wrong call. He responded “Negative” and instructed him to stop his climb at 6000ft. He then transferred the B747 pilot to the Heathrow INT S controller. Shortly afterwards he saw the STCA flash white, highlighting the B767 and the B747 in the hold. He realised his mistake and tried to call the Heathrow INT S controller; the strip-marking on the CCTV of the OCK stack indicated that the Heathrow INT S controller had spotted the conflict and had issued a heading to resolve it.

In looking at the risk in this incident, the Board noted that the required separation had not been achieved (400ft vs 1000ft required in the hold) and that avoiding action had been given by ATC. As result, they considered that this could not be considered a situation where 'normal procedures safety standards and parameters had pertained' (Category E). Notwithstanding, they also noted that the horizontal separation was 2.6nm at CPA, and they considered that the combined action taken by the B747 pilot and the avoiding-action issued by the INT S controller had both been timely and effective in preventing the possibility of the aircraft colliding. Therefore, the Board categorised the Airprox as risk Category C.

Cause: The TC South controller cleared the B747 pilot to descend into conflict with the B767 already in the hold.
