AIRPROX REPORT No 2015215

Date: 31 Oct 2015 Time: 1149Z Position: 5154N 00210W Location: Gloucestershire Airport

PART A: SUMMARY OF INFORMATION REPORTED TO UKAB

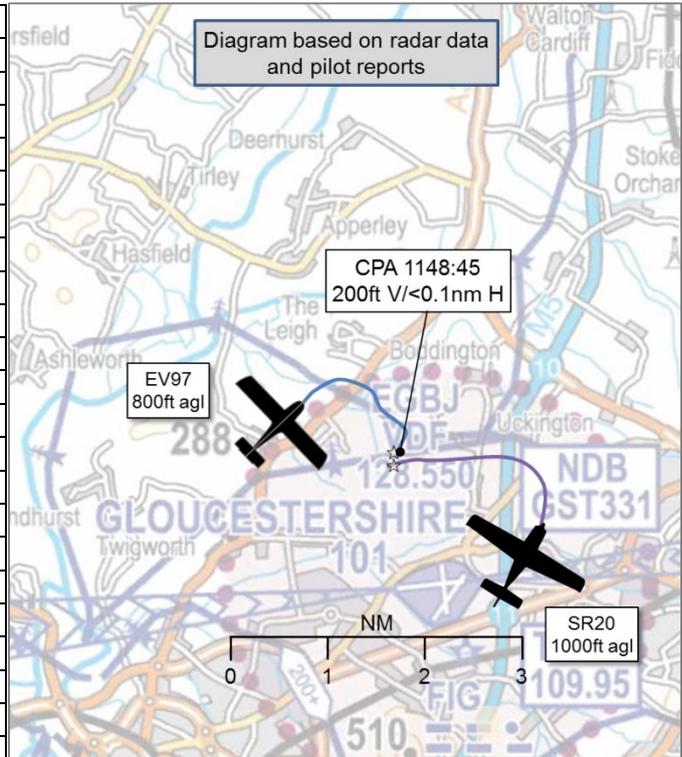
Recorded	Aircraft 1	Aircraft 2
Aircraft	SR20	EV97
Operator	Civ Trg	Unknown
Airspace	Gloster ATZ	Gloster ATZ
Class	G	G
Rules	VFR	VFR
Service	Aerodrome	Aerodrome
Provider	Gloster Tower	Gloster Tower
Altitude/FL	1000ft	900ft
Transponder	A, C, S	A, C, S
Reported		Not reported
Colours	White	
Lighting	Strobe	
Conditions	VMC	
Visibility	>10km	
Altitude/FL	1100ft	
Altimeter	QFE	
Heading	300°	
Speed	95kt	
TCAS/TAS	TCAS I	
Alert	None	
Separation		
Reported	100ft V/0 H	NK
Recorded	200ft V/<0.1nm H
