AIRPROX REPORT No 2015218

Date: 4 Dec 2015 Time: 1605Z Position: 5320N 00240W Location: 6.5nm E Liverpool Airport

PART A: SUMMARY OF INFORMATION REPORTED TO UKAB

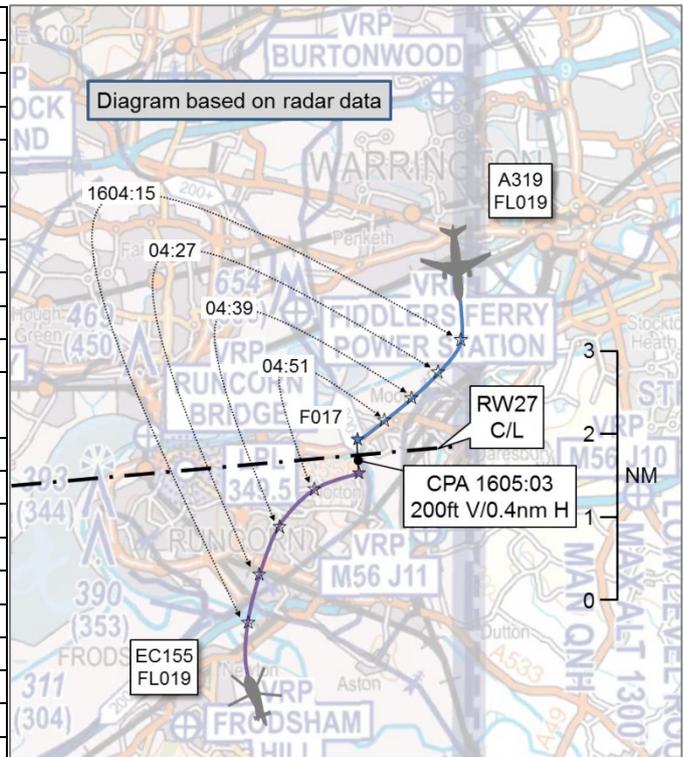
| Recorded | Aircraft 1 | Aircraft 2 |
|---|---|---|
| Reported | 300ft V/1nm H | 50ft V/0.5nm H |
| Recorded | 200ft V/0.4nm H | |
