**AIRPROX REPORT No 2016014**

Date: 11 Feb 2016 Time: 1536Z Position: 5130N 00019E Location: E of South Ockendon

**PART A: SUMMARY OF INFORMATION REPORTED TO UKAB**

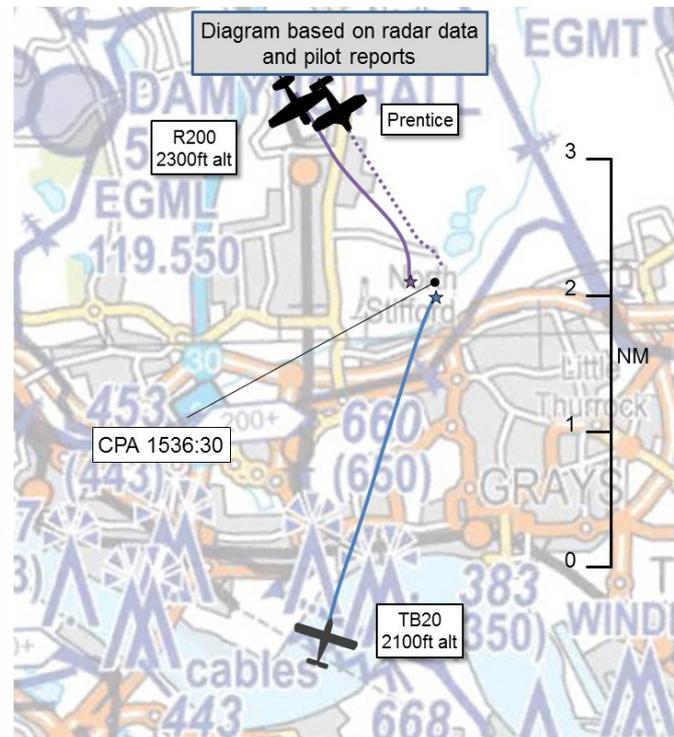
Figure 1 shows the relative positions of both the TB20 and the R200 at the time the TB20 reported seeing the first aircraft in their "9 or 10 o'clock". The Prentice was not observed on radar and it was not possible therefore to determine CPA. Neither the TB20, the R200 nor the Prentice made any reference to an Airprox whilst in communication with Farnborough Radar.
