**AIRPROX REPORT No 2016018**

Date: 16 Feb 2016 Time: 1555Z Position: 5145N 00100W Location: 10nm N Benson

**PART A: SUMMARY OF INFORMATION REPORTED TO UKAB**

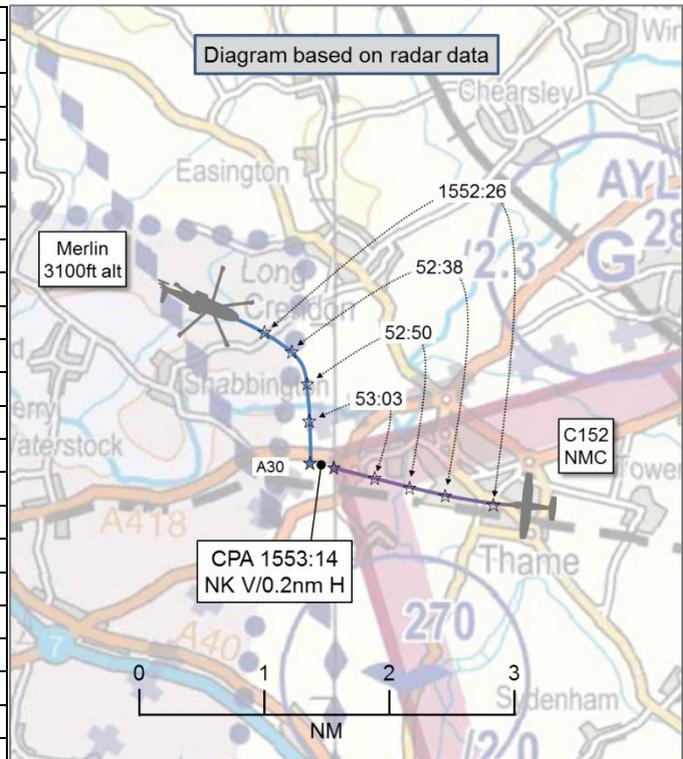
**THE MERLIN PILOT** reports that he was conducting a compass calibration flight and receiving a Traffic Service from Benson Approach. The controller called traffic ‘9 o’clock, 1nm’. The pilot looked in the direction of the traffic and saw a high-wing Cessna between 150 and 200ft below at a range of no more than 200m, it flew directly below his aircraft. It was too late to take any avoiding action and it appeared that the other pilot didn’t change course or level either. The pilot asked ATC if they had contact with the other pilot and whether he had been visual; they replied that he was receiving a service from another controller, was at 2200ft, and had not been visual with them. If ATC had not called the traffic, and if they had been any lower, the pilot thought that there would have been a very high risk of collision. During the compass calibration, workload was moderate, with the handling pilot flying the octagonal pattern and the non-handling pilot looking out; the crewman was also assisting with look-out and neither had seen the other aircraft. He noted that it was hazy and the white colour of the other aircraft made it difficult to see.

In looking at the cause, the Board agreed that the root of the incident lay in a late sighting by the Merlin pilot and a non-sighting by the C152 pilot. However they also agreed that Benson ATC had had a part to play, and that a contributory factor was the late Traffic Information by Benson ATC. Turning to the risk, the Board thought that the balance of probability was that the separation was in the region of 800ft and that this was therefore a Category C incident with no risk of collision.

Cause: A late sighting by the Merlin pilot and a non-sighting by the C152 pilot.
