**AIRPROX REPORT No 2016025**

Date: 4 Mar 2016 Time: 1014Z Position: 5252N 00026W Location: 9nm S Cranwell

**PART A: SUMMARY OF INFORMATION REPORTED TO UKAB**

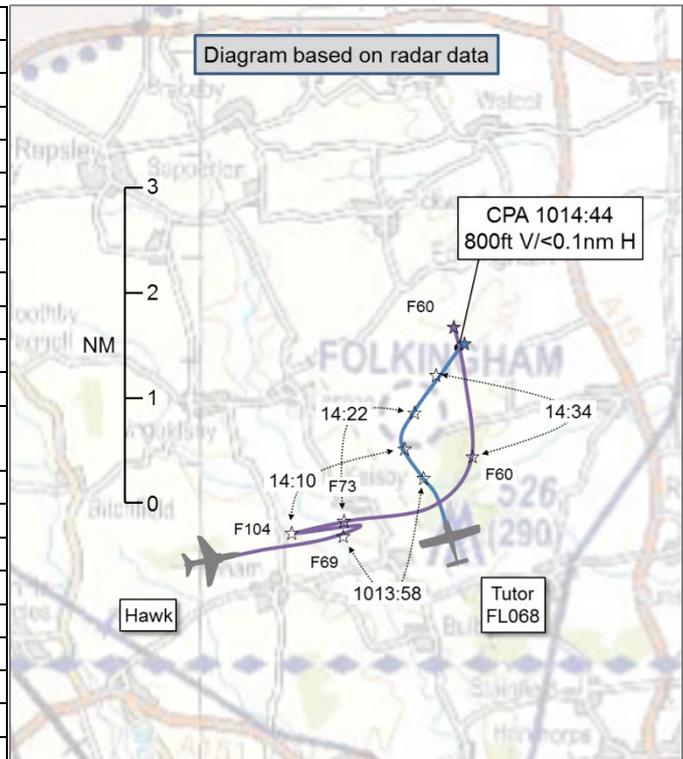
Recorded	Aircraft 1	Aircraft 2
Aircraft	Tutor	Hawk T1
Operator	HQ Air (Trg)	HQ Air (Ops)
Airspace	Lincs AAIA	Lincs AAIA
Class	G	G
Rules	VFR	VFR
Service	Traffic	Traffic
Provider	Cranwell	Waddington
Altitude/FL	FL68	FL60
Transponder	A, C, S	A, C
<b>Reported</b>		
Colours	White	Mil colours
Lighting	White HISL, Nav, LED landing	NK
Conditions	VMC	VMC
Visibility	10km	10km
Altitude/FL	6000ft	NK
Altimeter	RPS (983hPa)	NK
Heading	350°	NK
Speed	100kt	NK
ACAS/TAS	TAS	Not fitted
Alert	TA	N/A
<b>Separation</b>		
Reported	200ft V/0m H	Not seen
Recorded	800ft V/<0.1nm H

The Board then considered the cause and risk of the Airprox. Some members wondered whether the cause had been that the Hawk pilot had turned and descended towards the Tutor after having been issued with Traffic Information about its presence. However, from the previous discussion it was acknowledged that it was possible that the Hawk pilot had not assimilated the information and, therefore, the Board considered that it was unfair to state a cause that implied that he had knowingly turned towards the Tutor. Equally, the Tutor pilot was given little warning of the impending conflict, and had been told by ATC that it was another Tutor (which would have had a slower closure rate) when in fact it was a fast-moving Hawk. Consequently, it was decided that neither pilot had been in a position to have materially influenced the outcome, and that the cause was best described simply as a conflict in Class G airspace. As for the risk, the Board debated at great length whether this had just stopped short of an actual collision (Category A), or whether proximity had been greater than this, albeit with safety margins being much reduced below the norm (Category B). Members noted that the Hawk pilot had not seen the Tutor as he turned and descended towards it, and that the Tutor pilot had only seen the Hawk as it had passed underneath after approaching from behind and initially above. Accepting that it had been highly fortuitous that they had not passed closer to each other, the Board also noted that the minimum vertical separation at the time of the Airprox was 800ft; the majority view was that 800ft separation did not constitute a situation that had just stopped short of an actual collision. It was therefore considered that the risk was Category B; safety margins had been much reduced below the norm.

<u>Cause:</u>	A conflict in Class G.
<u>Contributory Factors:</u>	1. The congested airspace of the Lincolnshire AIAA. 2. The Hawk was not fitted with a TAS/TCAS.
<u>Degree of Risk:</u>	B.
<u>Recommendation:</u>	HQ Air Command review the coordination of military activity in the Lincolnshire AIAA.
