AIRPROX REPORT No 2016066

Date: 09 Apr 2016 Time: 0929Z Position: 5136N 00013E Location: SSE LAM VOR/DME

PART A: SUMMARY OF INFORMATION REPORTED TO UKAB

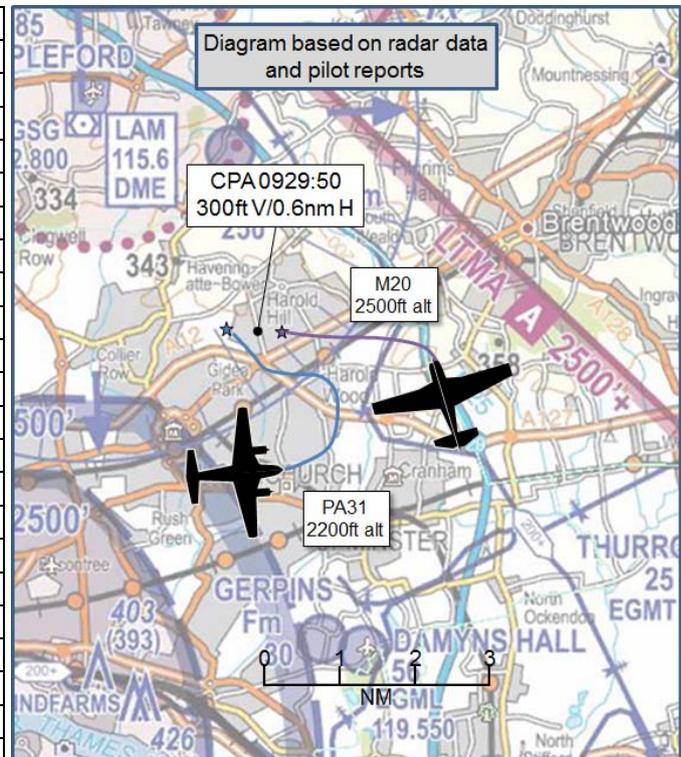
Recorded	Aircraft 1	Aircraft 2
Aircraft	PA31	Mooney M20
Operator	Civ Comm	Civ Trg
Airspace	London FIR	London FIR
Class	G	G
Rules	VFR	IFR
Service	Traffic	Basic
Provider	Thames Radar	Southend
Altitude/FL	2200ft	2500ft
Transponder	C	S
Reported		
Colours	White/Red/Blue	White
Lighting	Strobe	Strobe
Conditions	IMC	IMC
Visibility	0km	NK
Altitude/FL	2400ft	2400ft
Altimeter	QNH	NK
Heading	360°	290°
Speed	140-160kt	130kt
ACAS/TAS	TAS	Not fitted
Alert	TA	N/A
Separation		
Reported	50ft V/200m H	50-100ft V/0m H
Recorded	300ft V/0.6nm H
