AIRPROX REPORT No 2016129

Date: 07 Jul 2016 Time: 1715Z Position: 5133N 00131W Location: 12 WSW Benson

PART A: SUMMARY OF INFORMATION REPORTED TO UKAB

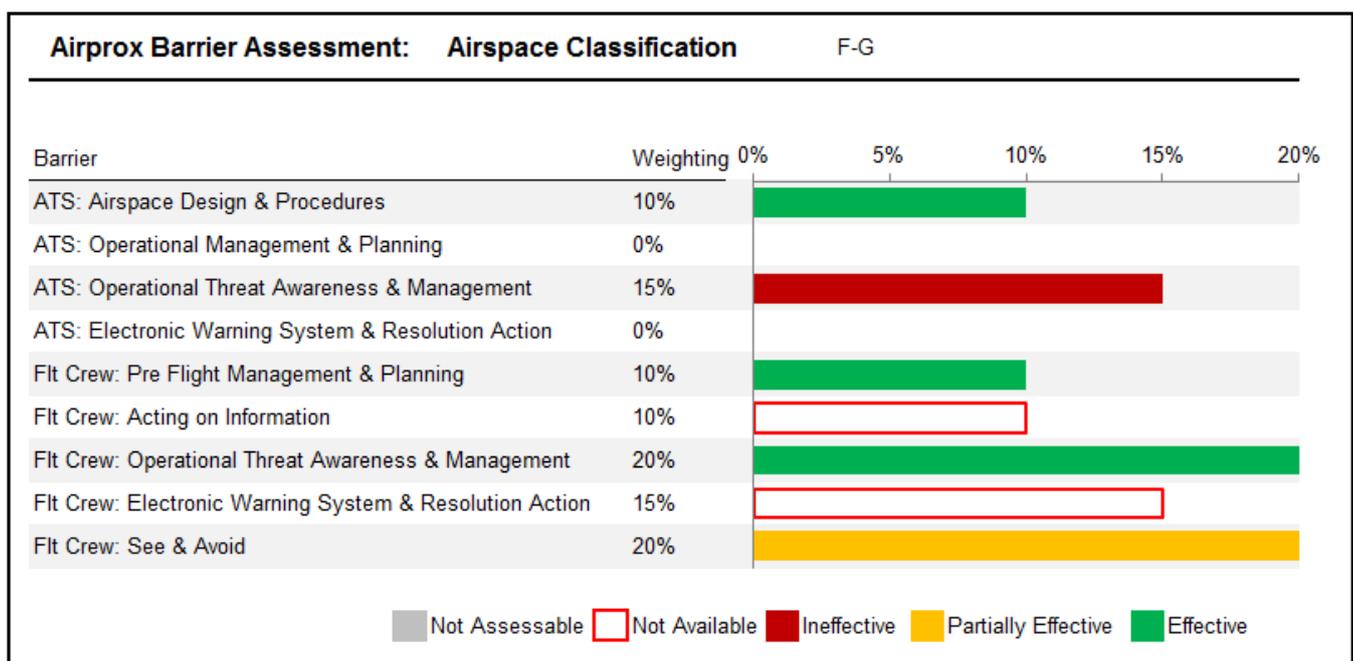
Barrier Assessment:

Modern safety management processes employ the concept of safety barriers that prevent contributory factors or human errors from developing into accidents. Based on work by EASA, CAA, MAA and UKAB, the following table depicts the barriers associated with preventing mid-air-collisions. The length of each bar represents the barrier's weighting or importance (out of a total of 100%) for the type of airspace in which the Airprox occurred (i.e. Controlled Airspace or Uncontrolled Airspace).^[1] The colour of each bar represents the Board's assessment of the effectiveness of the associated barrier in this incident (either Fully Effective, Partially Effective, Ineffective, Not Available, or Not Assessable). The chart thus illustrates which barriers were effective and how important they were in contributing to collision avoidance in this incident.
