AIRPROX REPORT No 2016160

Date: 22 Jul 2016 Time: 1202Z Position: 5120N 00257W Location: Weston-Super-Mare

PART A: SUMMARY OF INFORMATION REPORTED TO UKAB

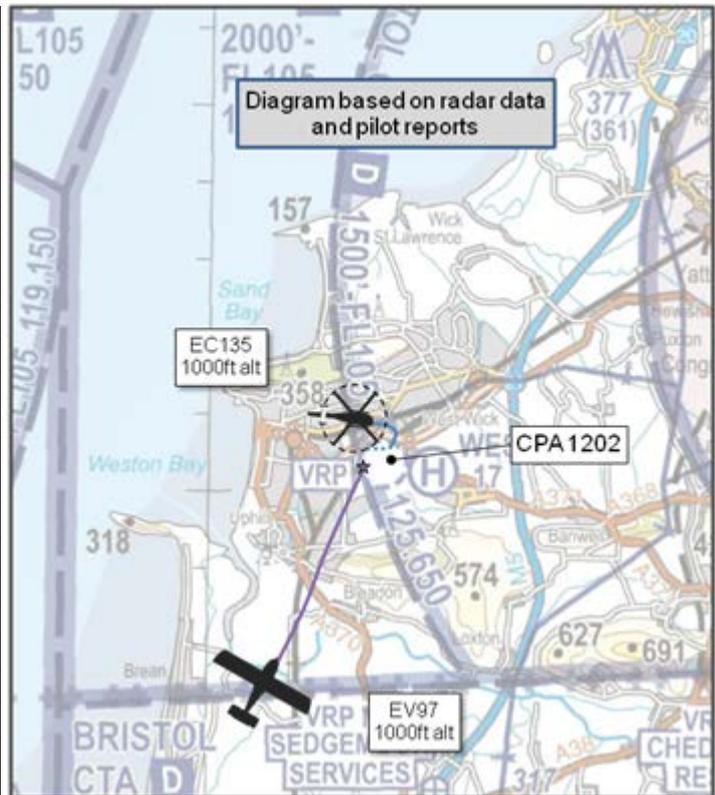
Recorded	Aircraft 1	Aircraft 2
Aircraft	EC135	EV97
Operator	NPAS	Civ Pte
Airspace	London FIR	London FIR
Class	G	G
Rules	VFR	VFR
Service	Basic	Listening out
Provider	Bristol	Bristol
Altitude/FL	NK	FL010
Transponder		A/C/S
Reported		
Colours	NPAS	Silver with red stripes
Lighting	NK	None
Conditions	VMC	VMC
Visibility	NK	>10km
Altitude/FL	1000ft	1050
Altimeter	QNH	QNH (1018hPa)
Heading	NK	026°
Speed	40-60kt	90kt
ACAS/TAS	TCAS I	Not fitted
Alert	Unknown	N/A
Separation		
Reported	NK V/0m H	100ft V/0m H
Recorded		NK

THE EUROCOPTER EC135 PILOT reports that he was in an orbit (at 1000ft, 40-60kts) on task in the Weston-Super-Mare area in support of Officers on the ground for approx 20mins. He was in receipt of a Basic Service from Bristol ATC, operating under their CTA. He received a TCAS activation "5 o'clock, same level". Avoiding action was initiated, descending to 700ft in the turn, all crew had 'eyes out'. A low-wing aircraft (possibly a PA28) was seen by the front crew member through the disc in the descent directly overhead. The orbit was continued until the pilot was visual with the aircraft before climbing back to 1000ft to continue the task. The fixed-wing aircraft's pilot made no deviation from heading throughout. An Airprox was reported to Bristol ATC.

THE EV97 EUROSTAR MICROLIGHT PILOT reports that he was on a cross-country flight via Bridgwater, Weston Aerodrome, Clevedon and the Old Severn Bridge to his destination in South Wales. His first sighting of the helicopter was probably from an area just north of Burnham-on-Sea, his heading approximately 030°. The helicopter was ahead of him at a safe distance crossing from right to left at the same altitude. He held visual contact whilst holding straight-and-level and checked his ASI at approximately 100mph. The helicopter pilot adopted a hover, still at a safe distance and still at a matching altitude. The helicopter was in view 35° left of ahead. He remained vigilant to future movement. The helicopter appeared to be facing him whilst holding the hover. Although he thought it likely that its pilot had seen him he could not assume that was the case. The helicopter pilot then began a return from left to right still at a safe distance ahead and this time descending. He estimated that the helicopter would be clear of his track ahead and sufficiently to the right and below his current height. He changed direction a few degrees to the left. As he continued to hold the helicopter in view, its pilot adopted what seemed a banking right turn onto a track which would pass to his right at a lower height. Before their relative tracks became abeam, the helicopter's track continued further to his right so that their tracks overlapped though still maintaining vertical separation. At this point he fed in more power. The helicopter was now out of sight, last seen

moving beneath him obscured by the starboard wing and what he believed to be diagonally to his back left. Notably he was unable to see any further changes in height. Choosing not to make any further change in direction or any manoeuvre that might suddenly degrade his own height he had gone to full throttle to increase speed and distance. He was satisfied that he was clear of the helicopter but realised that its last movement suggested that he may not have been seen after all. This was confirmed when the helicopter pilot reported to Bristol Radar that an aeroplane had 'just flown over' him and he wished to report an Airprox, which was acknowledged by Bristol ATC. Now being sure that he was clear he was able to gain height for the water crossing from Portishead to the Old Severn Bridge, enroute to his destination.
