AIRPROX REPORT No 2016199

Date: 14 Sep 2016 Time: 1406Z Position: 5113N 00005W Location: 8nm ENE Gatwick airport

PART A: SUMMARY OF INFORMATION REPORTED TO UKAB

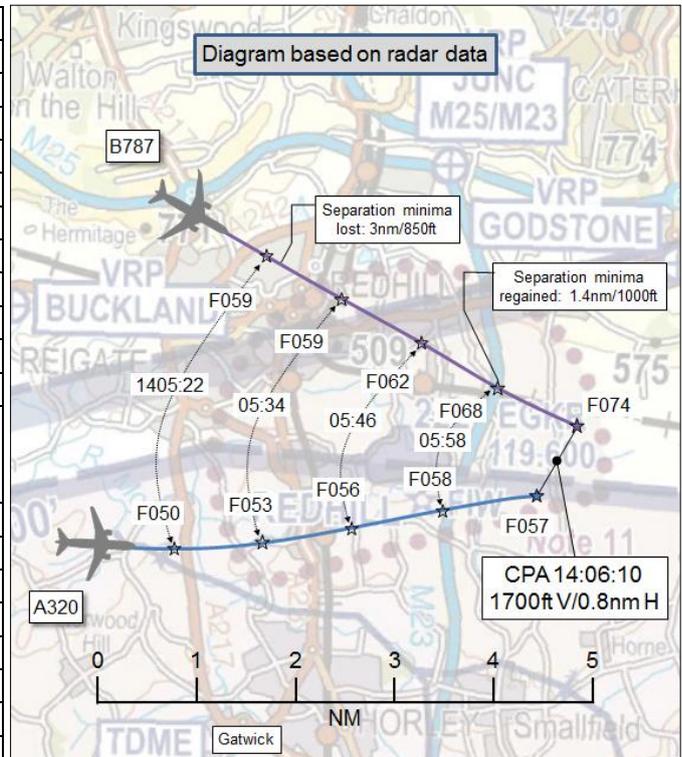
Recorded	Aircraft 1	Aircraft 2
Aircraft	A320	B787
Operator	CAT	CAT
Airspace	London TMA	London TMA
Class	A	A
Rules	IFR	IFR
Service	Radar Control	Radar Control
Provider	Swanwick TC	Swanwick TC
Altitude/FL	5600ft	6200ft
Transponder	A,C,S	A,C,S
Reported		
Colours	Company	NK
Lighting	Landing, beacon, strobes, Logo, nav	NK
Conditions	VMC	NK
Visibility	50km	NK
Altitude/FL	5800ft	NK
Altimeter	QNH	NK
Heading	095°	NK
Speed	250kt	NK
ACAS/TAS	TCAS II	TCAS II
Alert	TA	Unknown
Separation		
Reported	600ft V/2nm H	NK
Recorded	500ft V/2.2nm H
