AIRPROX REPORT No 2016201

Date: 11 Sep 2016 Time: 1517Z Position: 5115N 00036W Location: 0.5nm W Guildford

PART A: SUMMARY OF INFORMATION REPORTED TO UKAB

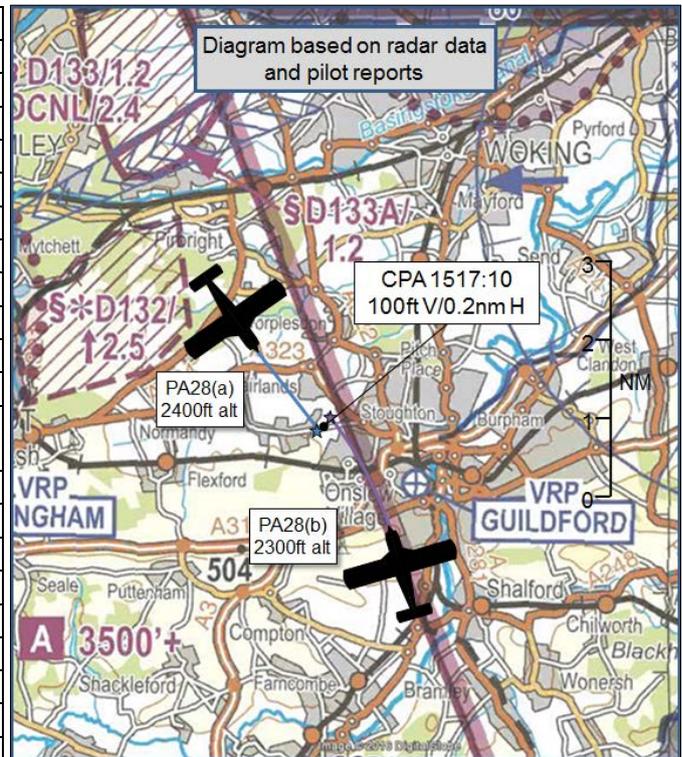
THE PA28(A) PILOT reports that he was in receipt of a [reduced] Traffic Service from Farnborough West but no Traffic information on the other aircraft was passed. As it was coming straight towards him its profile in his field of vision was small; it did not appear to move and he did not pick up on it during his scan. He did not observe the aircraft until it passed to his left, which was disconcerting as he was about to turn left. A moment sooner and there would have been a collision. By the time he saw the other aircraft, avoiding action was not required and was not possible. A standard turn to the right would have been appropriate, if seen earlier. He opined that despite Farnborough's provision of a Traffic Service, he felt that the West ATCO was overloaded with proper resource not given to this position. There were multiple aircraft on frequency in the area at the time and he opined that the ATCO's priority was not to provide a Traffic Service, but to manage aircraft mostly in receipt of Basic Service in order to provide deconfliction for IFR aircraft, not on the same frequency. The weather conditions at the time of the incident were CAVOK, but in this busy piece of airspace on a sunny Sunday afternoon a Traffic Service is a useful, perhaps even essential, tool for GA aircraft. He was using a PilotAware unit connected to his iPad with Skydemon but the other aircraft did not show on this equipment and no warning was received.

He assessed the risk of collision as 'High'.

THE PA28(B) PILOT reports that he did not see the other aircraft.
