AIRPROX REPORT No 2016238

Date: 14 Nov 2016 Time: 1038Z Position: 5420N 00109W Location: 18nm E RAF Leeming

PART A: SUMMARY OF INFORMATION REPORTED TO UKAB

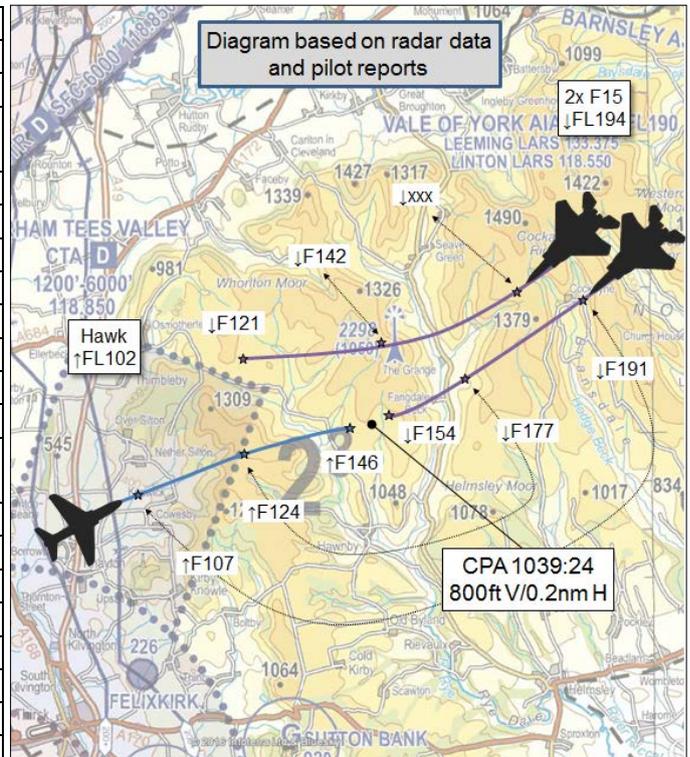
Recorded	Aircraft 1	Aircraft 2
Aircraft	Hawk	F15
Operator	HQ Air (Ops)	Foreign Mil
Airspace	Vale of York AIAA	Vale of York AIAA
Class	G	G
Rules	VFR	VFR
Service	Traffic	Traffic
Provider	Leeming	Swanwick Mil
Altitude/FL	FL146	FL154
Transponder	A,C,S	A,C,S
Reported		
Colours	Black	Dark Grey
Lighting	Strobes, Nav and landing	
Conditions	VMC	VMC
Visibility	20km	
Altitude/FL	15000ft	
Altimeter	RPS (1019hPa)	NK
Heading	090°	270°
Speed	300kt	494kt
ACAS/TAS	Not fitted	Not fitted
Separation		
Reported	2-300ft V/>1nm H	1000ft V/0.4nm H
Recorded	800ft V/0.2nm H
