**AIRPROX REPORT No 2016002**

Date: 8 Jan 2016 Time: 1441Z Position: 5134N 00015E Location: 6nm E London City

**PART A: SUMMARY OF INFORMATION REPORTED TO UKAB**

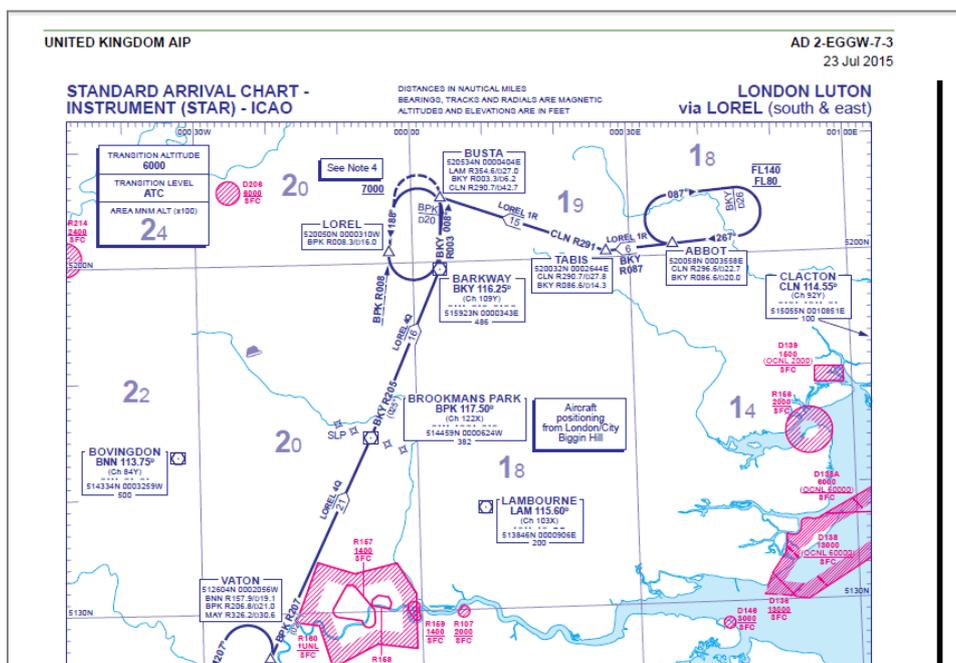
Figure 1 Luton LORL STAR.

Figure 1 shows the appropriate part of the Luton STAR from BPK, which is applicable to inbounds from Biggin Hill.
