**AIRPROX REPORT No 2016012**

Date: 4 Feb 2016 Time: 1050Z Position: 5154N 00213W Location: Gloucestershire ATZ

**PART A: SUMMARY OF INFORMATION REPORTED TO UKAB**

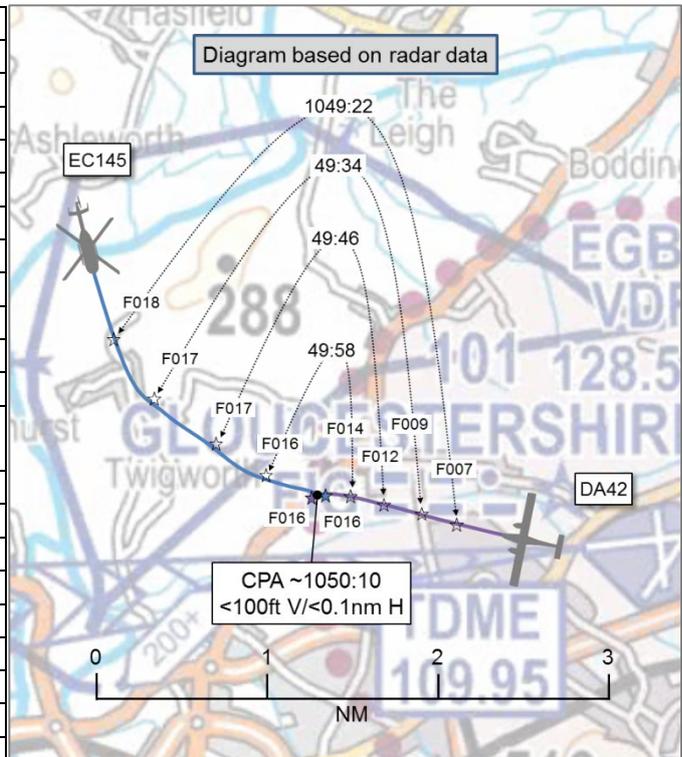
Recorded	Aircraft 1	Aircraft 2
Aircraft	EC145	DA42
Operator	HEMS	Civ Trg
Airspace	Gloster ATZ	Gloster ATZ
Class	G	G
Rules	VFR	IFR
Service	Aerodrome	Procedural
Provider	Gloster	Gloster
Altitude/FL	1600ft	1500ft
Transponder	A, C, S	A, C, S
<b>Reported</b>		
Colours	Yellow	Mainly white
Lighting	Strobes, anti-col, nav, landing, flood	Strobes, landing
Conditions	VMC	VMC
Visibility	>10km	>20km
Altitude/FL	2000ft	2400ft
Altimeter	QFE (1022hPa)	QNH (1025hPa)
Heading	090°	285°
Speed	90kt	100kt
ACAS/TAS	TCAS I	Not fitted
Alert	TA	N/A
<b>Separation</b>		
Reported	0ft V/100-150m H	Not seen
Recorded	<100ft V/<0.1nm H

When considering the risk, the Board took into account that neither pilot saw the other traffic in time to take any avoiding action. The EC145 pilot reported that the DA42 had passed through their level at approximately 100-150m and, by the time it had been seen, it was passing down the right-hand side of the helicopter. The Board noted that the EC145 had been equipped with TCAS 1 and that this had shown the presence of traffic below the helicopter which had surprised the pilot because the only traffic he had been informed of was 1000ft above him. Members opined that this confusion had probably delayed him making visual acquisition of the DA42 as he tried to reconcile the conflicting information. The radar recordings show that the two aircraft passed less than 100ft apart vertically and less than 0.1nm horizontally. In view of the very close miss distance, the fact that the DA42 pilot did not see the EC145, and that neither pilot had been able to take any avoiding action, the Board considered that luck had played a major part and that it had been purely fortuitous that a collision had not occurred. Consequently, the Airprox was assessed as risk Category A.
