**AIRPROX REPORT No 2016065**

Date: 03 May 2016 Time: 1239Z Position: 5236N 00006W Location: SSW Fenland

**PART A: SUMMARY OF INFORMATION REPORTED TO UKAB**

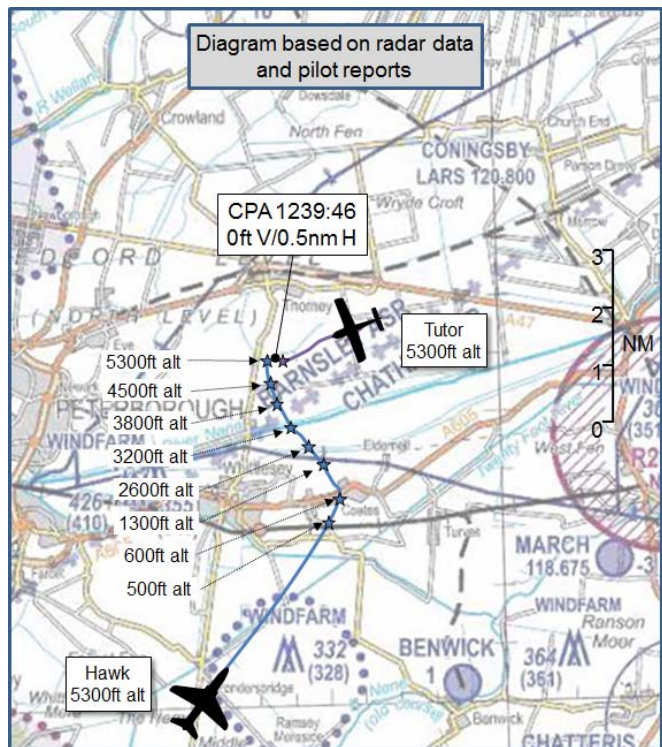
**THE HAWK PILOT** reports that he was climbing out of low-level. He was the pilot in the front seat with a QFI pilot in the rear seat. During the climb out of low-level he was in the process of obtaining radar contact from Swanwick Mil East. As part of that radar pick up he was asked to change his IFF code so that they could acquire him on radar. Whilst he was in the process of looking inside the cockpit to change his IFF, the pilot in the back seat informed him that he had just observed a light-aircraft close to their position. The aircraft was a single engine, low-wing light-aircraft. It was observed in the 3 o'clock position, initially coming towards their track but then turning left away in a southerly direction.

The Hawk pilot reported climbing out of low-level. During the climb-out they were in the process of obtaining a radar service from Swanwick Mil, whilst the front-seat pilot was changing the IFF, the rear-seat pilot observed the Tutor close to their position. The radar replays show that the Hawk IFF did not change until CPA had passed but this may be due to radar update rate. The pilot's report and radar replay indicate that the front-seat pilot was likely head in the cockpit changing the IFF as the aircraft closed on each other.

The Board then turned to the cause and risk of the Airprox. They quickly determined that the Tutor pilot had full SA throughout the incident, but they thought that the Hawk pilots had probably been startled by the unexpected presence of the Tutor as they were engaged in climbing out of low-level and contacting Swanwick(Mil). Noting the recorded 0.5nm separation and the different perspective of the incident that had resulted from the Hawk pilots' lack of SA, members agreed that the incident was probably best described simply as the Hawk pilot being concerned by the proximity of the Tutor. Turning to the risk of collision, the Board agreed that the Tutor pilot was visual with the Hawk throughout the incident and that no risk of collision had existed; they therefore assessed the risk as Category C.

Cause: The Hawk pilot was concerned by the proximity of the Tutor.
