AIRPROX REPORT No 2016088

Date: 23 May 2016 Time: 1148Z Position: 5109N 00134W Location: Middle Wallop airfield
Elevation 297ft.

PART A: SUMMARY OF INFORMATION REPORTED TO UKAB

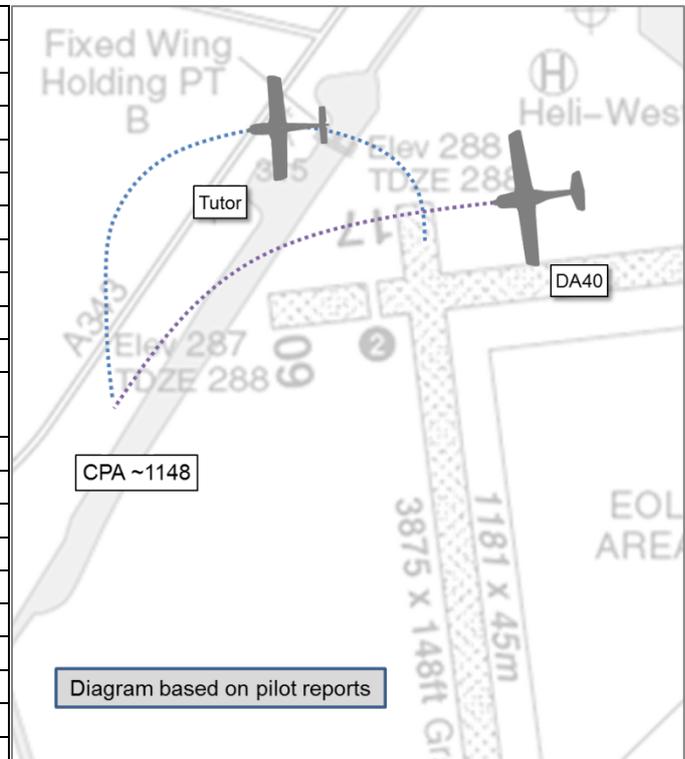
Recorded	Aircraft 1	Aircraft 2
Aircraft	DA40	Tutor
Operator	Civ Trg	HQ Air (Trg)
Airspace	ATZ	ATZ
Class	G	G
Rules	VFR	VFR
Service	Aerodrome	Aerodrome
Provider	Middle Wallop	Middle Wallop
Transponder	A,C,S	A,C,S
Reported		
Colours	White	White
Lighting	Strobes, nav, landing	HISL, nav
Conditions	VMC	VMC
Visibility	40km	>10km
Altitude/FL	1300ft	1000ft
Altimeter	QFE	QFE (1008hPa)
Heading	260°	175°
Speed	95kt	80kt
ACAS/TAS	Not fitted	Not fitted
Separation		
Reported	150ft V/300m H	100ft V/200m H
Recorded	NK

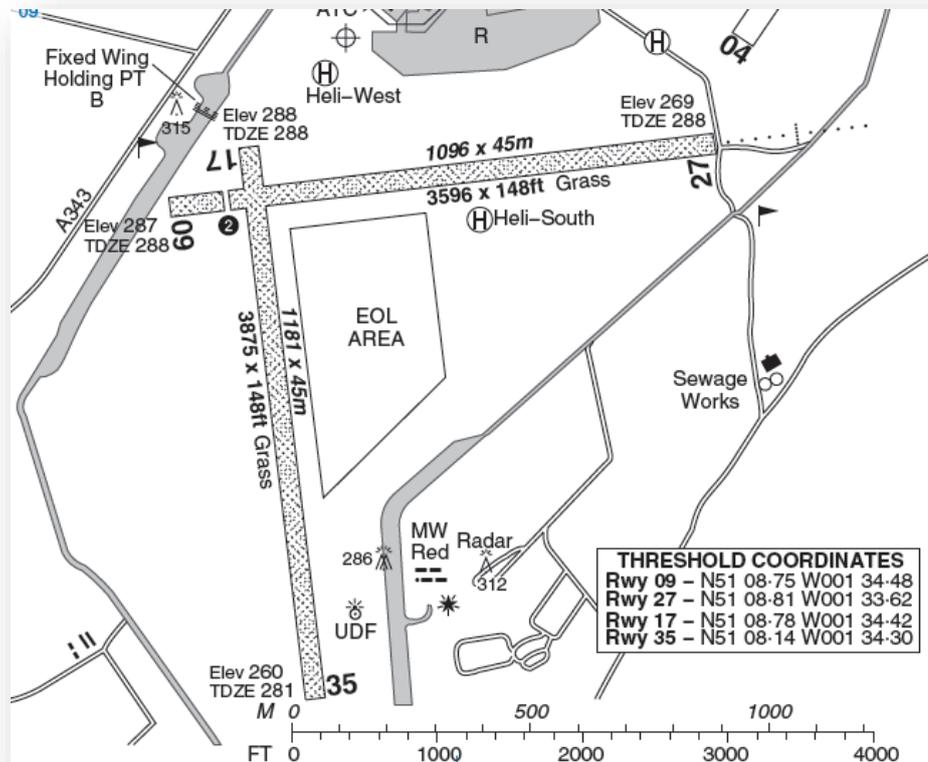
Figure 1.

Figure 1 shows the airfield layout from the UK MIL AIP. With the exception of a short hard-surface helicopter runway, the entire Middle Wallop airfield is grass. To the east of RW35 is the Engine Off Landing (EOL) Area; aircraft overflying this area do so at a minimum of 1500ft in order to remain 500ft above the helicopter traffic operating in the EOL.
