AIRPROX REPORT No 2016124

Date: 30 Jun 2016 Time: 1108Z Position: 5115N 00109W Location: 7nm NW Odiham

PART A: SUMMARY OF INFORMATION REPORTED TO UKAB

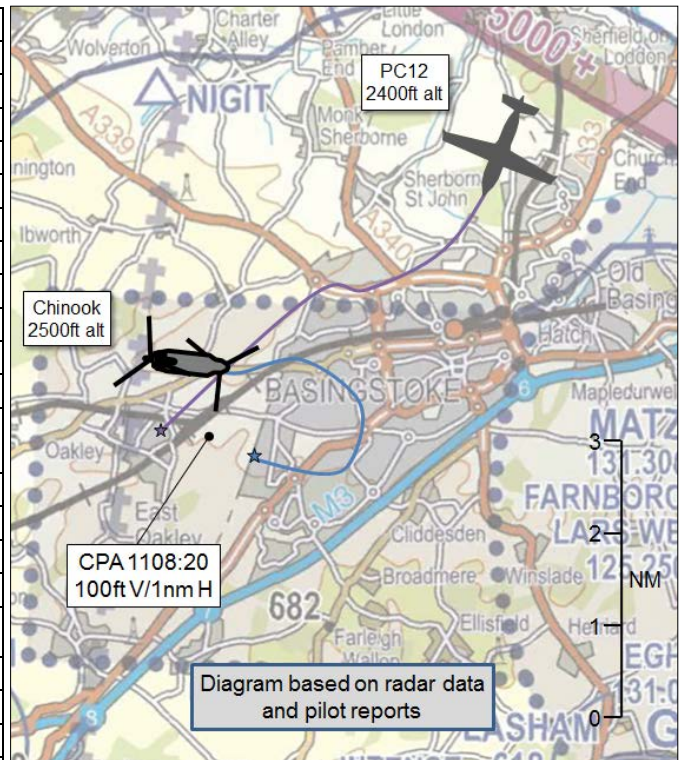
Recorded	Aircraft 1	Aircraft 2
Aircraft	Chinook	PC12
Operator	Civ Comm	Civ Comm
Airspace	Odiham MATZ	Lon FIR
Class	G	G
Rules	VFR	VFR
Service	Traffic	Basic
Provider	Odiham	Farnborough
Altitude/FL	2500ft	2400ft
Transponder	A, C, S	A, C, S
Reported		
Colours	Green	Blue, Silver
Lighting	Nav, Anti-Cols, Landing	NK
Conditions	IMC	VMC
Visibility	1.5km	
Altitude/FL	2000ft	2400ft
Altimeter	QNH (995hPa)	
Heading	270°	
Speed	NK	
ACAS/TAS	Not fitted	TAS
Separation		
Reported	0ft V/0.4nm H	NK
Recorded	100ft V/1nm H

THE CHINOOK PILOT reports that he was on a radar heading for a PAR recovery to Odiham, IMC, at, he believed, 2000ft. At approximately 7nm to Odiham, ATC asked the crew to hold in their current position by way of a 360° turn. The crew commenced the turn, during which ATC asked whether they were visual with the traffic ahead; this caused the crew some concern because they weren't visual and were intermittent IMC. Whilst still in the left-hand turn [UKAB note: he recalled it was LH but in fact it was a RH turn as shown on radar] the PM noticed a fixed-wing aircraft in the 2 o'clock position at the same height, on a similar, but closing heading and estimated to be within 0.5nm. He made the PF aware of the traffic, who decided to initially stop the turn to remain VMC and then turn right to avoid a potential collision. Once clear of the traffic, ATC resumed vectors for the PAR.
