AIRPROX REPORT No 2016156

Date: 28 Jul 2016 Time: 1211Z Position: 5146N 00003E Location: Lambourne hold

PART A: SUMMARY OF INFORMATION REPORTED TO UKAB

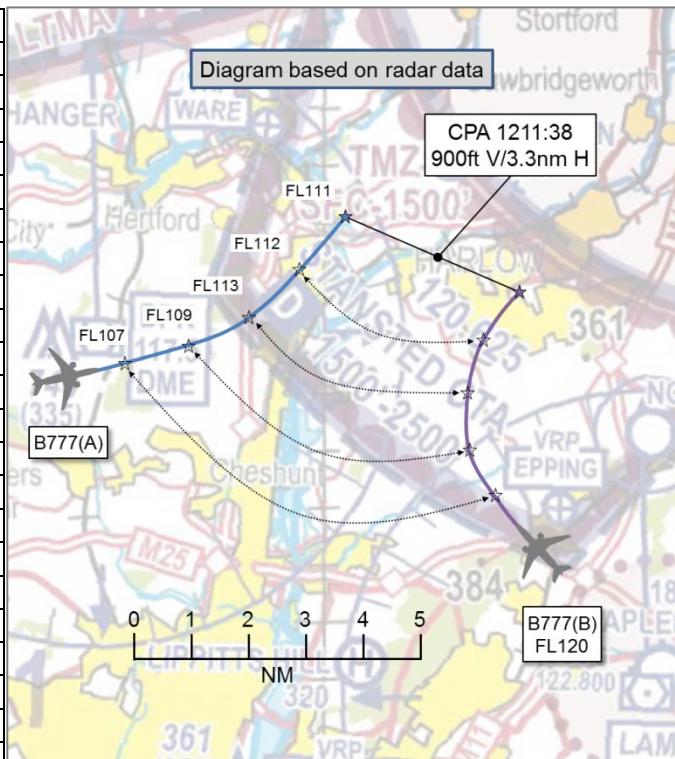
Recorded	Aircraft 1	Aircraft 2
Aircraft	B777(A)	B777(B)
Operator	CAT	CAT
Airspace	London TMA	London TMA
Class	A	A
Rules	IFR	IFR
Service	Radar Control	Radar Control
Provider	Swanwick TC	Swanwick TC
Altitude/FL	FL111	FL120
Transponder	A, C, S	A, C, S
Reported		
Colours	Company	Company
Lighting	NK	NK
Conditions	VMC	NK
Visibility	>10km	>10km
Altitude/FL	FL110	FL120
Heading	040°	NK
Speed	259kt	235kt
ACAS/TAS	TCAS II	TCAS II
Alert	TA	Unknown
Separation		
Reported	800ft V/3nm H	NK
Recorded	800ft V/3.3nm H

THE BOEING 777(A) PILOT reports that the other B777, which was in the LAM hold, turned right rather than left at FL120. The B777(A) was in a climb to FL150 direct REDFA when ATC gave them avoiding action instructions; left heading 040°, to stop climb at FL110. Given their rate of climb and the timing of the instruction, there was a subsequent altitude bust to FL114. ATC were made aware and they returned to FL110.

According to the unit report, the pilot of B777(B) reported that a discrepancy between the charts and the programming of the FMS had caused the error, which he had not become aware of until the aircraft began a right turn. The aircraft were operating in Class A airspace where ATC are responsible for separating the aircraft. Separation was maintained due to the timely action taken by the controllers involved.

The Board then turned its attention to the cause and risk of the Airprox. It was quickly and unanimously agreed that the Airprox had occurred because the B777(B) pilots had incorrectly programmed their FMS and turned towards the B777(A). In debating the risk, some members felt that although standard separation had been maintained, this was not a usual occurrence in controlled airspace and so normal procedures should not be considered to have pertained. However, the majority view was that although it was recognised as an unusual occurrence for an aircraft to turn in the wrong direction when entering a hold, the action taken by ATC had ensured that normal safety standards and parameters had been maintained between the aircraft. They opined that, although the incident met the criteria for reporting, subsequent analysis had showed that this was a benign, non-proximate situation with no possibility of a collision. The majority view prevailed, and the Airprox was assessed accordingly as risk Category E.
