AIRPROX REPORT No 2016177

Date: 16 Aug 2016 Time: 1039Z Position: 5154N 00218W Location: 7nm W Gloucestershire airport

PART A: SUMMARY OF INFORMATION REPORTED TO UKAB

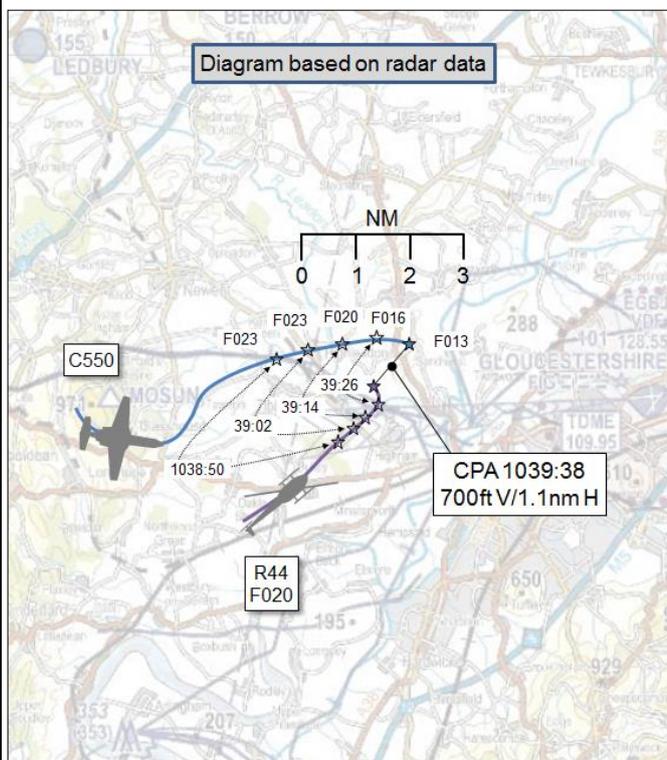
Recorded	Aircraft 1	Aircraft 2
Aircraft	C550	R44
Operator	Civ Comm	Civ Trg
Airspace	London FIR	London FIR
Class	G	G
Rules	IFR	VFR
Service	Procedural	Basic
Provider	Gloster	Gloster
Altitude/FL	FL20	FL19
Transponder	A,C,S	A,C,S
Reported		
Colours	Mainly white	Green/silver
Lighting	NK	NK
Conditions	VMC	VMC
Visibility	>10km	>10km
Altitude/FL	2500ft	NK
Altimeter	QNH (1020hPa)	NK
Heading	086°	NK
Speed	100-200kt	NK
ACAS/TAS	TCAS II	Not fitted
Alert	Proximate	N/A
Separation		
Reported	300ft V/1nmH	Not seen
Recorded	700ft V/1.1nm H	100ft V/1.5nm H
