AIRPROX REPORT No 2016191

Date: 06 Aug 2016 Time: 1141Z Position: 5048N 00031W Location: 1nm S Littlehampton

PART A: SUMMARY OF INFORMATION REPORTED TO UKAB

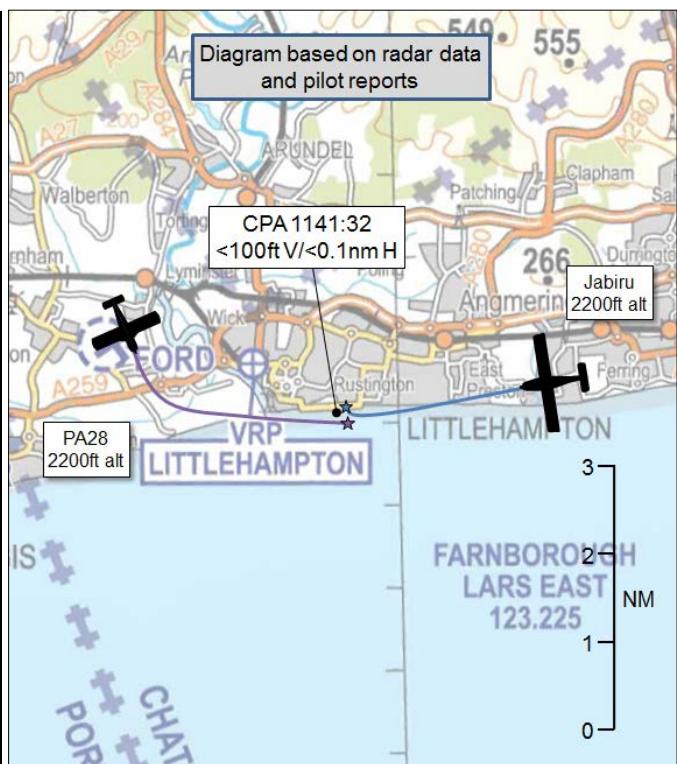
| Recorded | Aircraft 1 | Aircraft 2 |
|---|---|---|
| Reported | 10ft V/20m H | 0ft V/500m H |
| Recorded | | 0ft V/0.1nm H |
