**AIRPROX REPORT No 2016210**

Date: 08 Sep 2016 Time: 1042Z Position: 5214N 00253W Location: Shobdon airfield

**PART A: SUMMARY OF INFORMATION REPORTED TO UKAB**

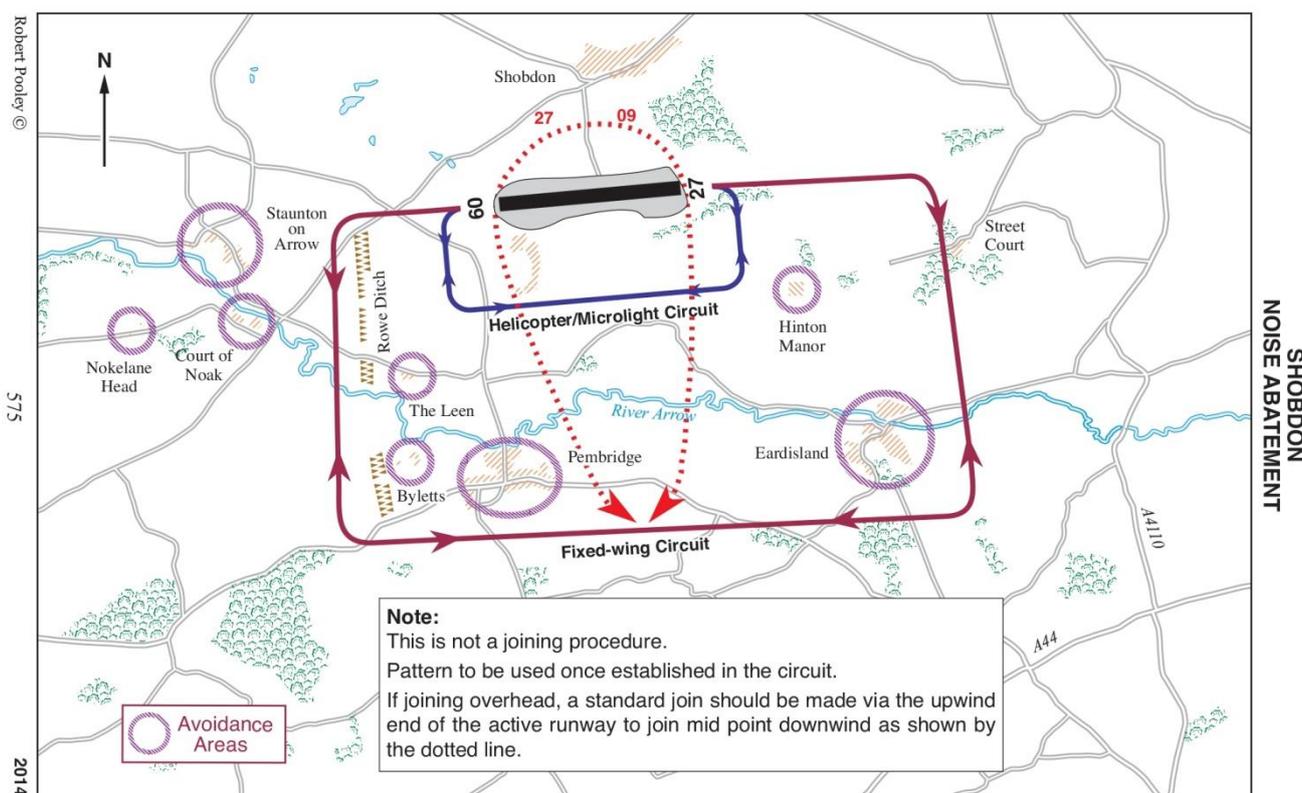
Figure 4 Shobdon Noise Abatement.

When the PA30 pilot reported overhead at 2000ft, the Shobdon AFISO requested that he descend not below 1500ft on the deadside for noise abatement reasons. The AFISO then passed Traffic Information on the RV9 to the PA30 pilot, describing the RV9 as being “ahead” and “also overhead”. The PA30 pilot reported to the AFISO that he was looking for the traffic. Figure 2 shows the traffic situation at 1041:35, with the PA30 pilot having descended deadside on a southerly track and the traffic believed to be the RV9 in a left-hand turn to the north of the aerodrome.
