AIRPROX REPORT No 2016252

Date: 29 Nov 2016 Time: 1146Z Position: 5046N 00108W Location: Solent

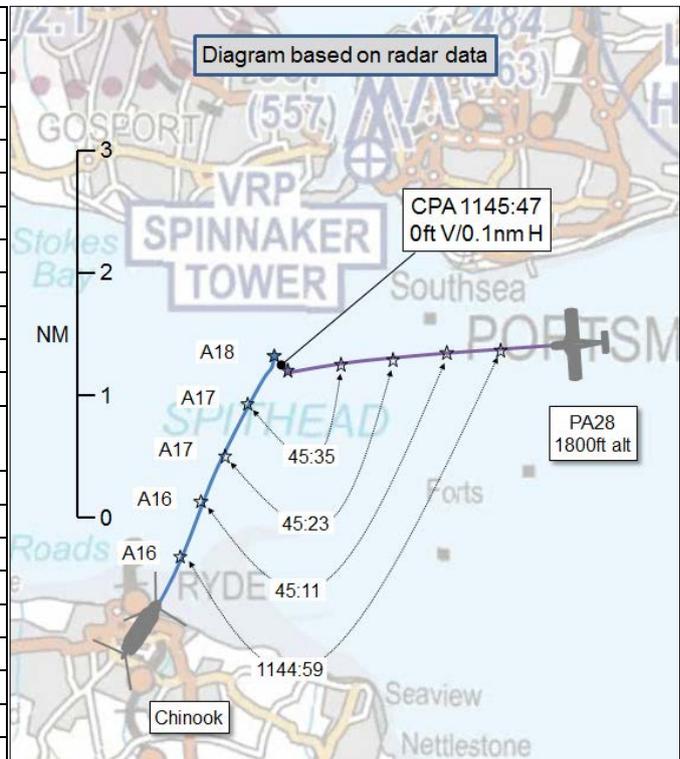
Recorded	Aircraft 1	Aircraft 2
Aircraft	Chinook	PA28
Operator	HQ JHC	Civ Pte
Airspace	London FIR	London FIR
Class	G	G
Rules	VFR	VFR
Service	Basic	Basic
Provider	Solent Radar	Solent Radar
Altitude/FL	1800ft	1800ft
Transponder	A,C,S	A,C,S
Reported		
Colours	Green	Burgundy/white
Lighting	White strobe, nav	NK
Conditions	VMC	VMC
Visibility	>10km	30km
Altitude/FL	1500ft	1800ft
Altimeter	QNH (1034hPa)	QNH (1033hPa)
Heading	015°	~250°
Speed	130kt	110kt
ACAS/TAS	TAS	Not fitted
Alert	TA	N/A
Separation		
Reported	Nil V/~200m H	NK V/~1nm H
Recorded	Nil V/0.1nm H
