AIRPROX REPORT No 2016254

Date: 05 Dec 2016 Time: 1143Z Position: 5149N 00118W Location: Oxford ATZ

PART A: SUMMARY OF INFORMATION REPORTED TO UKAB

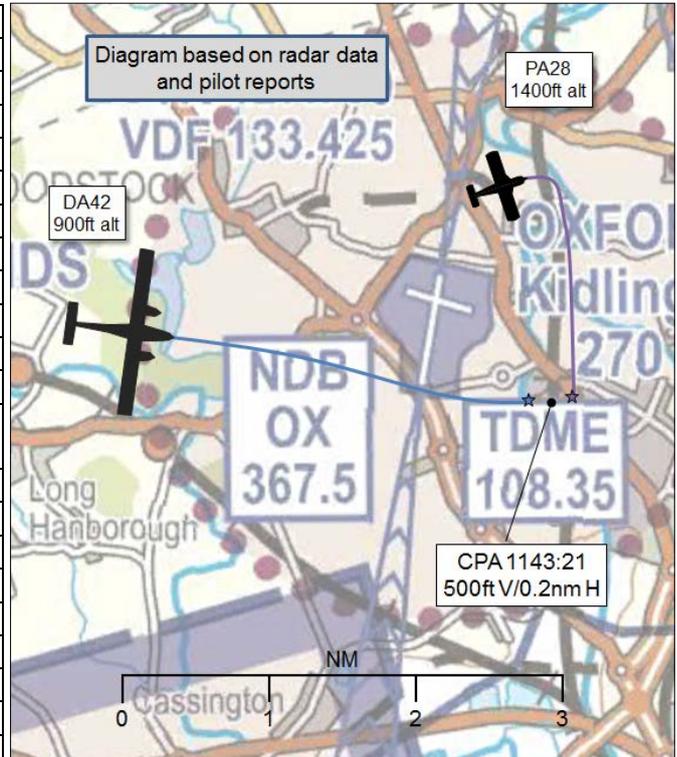
Recorded	Aircraft 1	Aircraft 2
Aircraft	DA42	PA28
Operator	Civ Trg	Civ Pte
Airspace	Oxford ATZ	Oxford ATZ
Class	G	G
Rules	IFR	VFR
Service	Aerodrome	Aerodrome
Provider	Oxford	Oxford
Altitude/FL	900ft	1400ft
Transponder	A, C, S	A, C
Reported		
Colours	White	White, Blue
Lighting	Strobes	Strobes, Nav, Landing
Conditions	VMC	VMC
Visibility	>10km	
Altitude/FL	800ft	1500ft
Altimeter	QNH (1023hPa)	QNH
Heading	100°	180°
Speed	100kt	80kt
ACAS/TAS	TAS	Not fitted
Alert	U/S	N/A
Separation		
Reported	700ft V	100ft V/100m H
Recorded	500ft V/0.2nm H
