AIRPROX REPORT No 2016268

Date: 20 Dec 2016 Time: 1256Z Position: 5124N 00309W Location: Lavernock Point, Cardiff

PART A: SUMMARY OF INFORMATION REPORTED TO UKAB

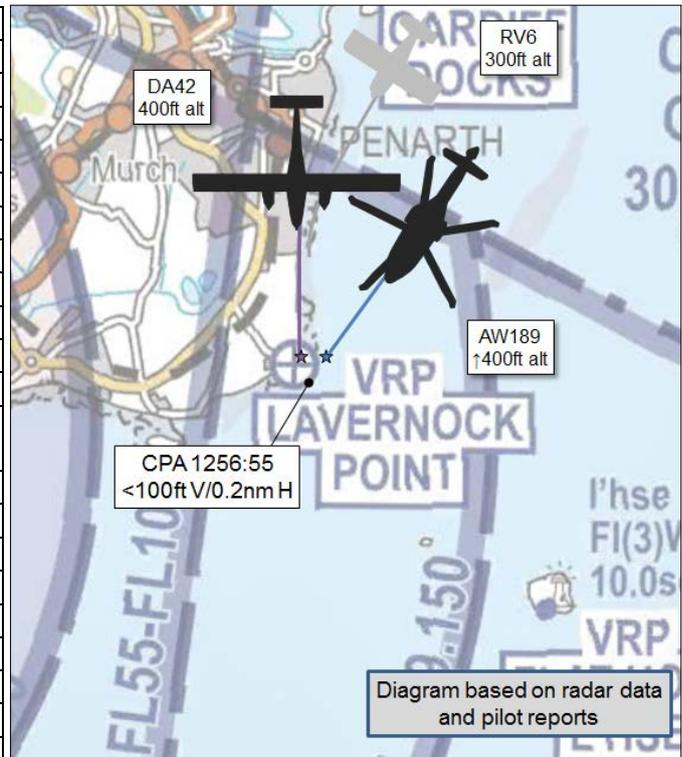
Recorded	Aircraft 1	Aircraft 2
Aircraft	AW189	DA42
Operator	HEMS	Civ Pte
Airspace	London FIR	London FIR
Class	G	G
Rules	VFR	VFR
Service	Aerodrome	Aerodrome
Provider	Cardiff	Cardiff
Altitude/FL	FL004	FL004
Transponder	A, C, S	A, C, S
Reported		
Colours	Red, White	White
Lighting	Landing, Anti-Cols, Nav	Strobes
Conditions	VMC	VMC
Visibility	8km	5-7km
Altitude/FL	600ft	800ft
Altimeter	QNH (1020hPa)	QNH
Heading	230°	NR
Speed	80kt	120kt
ACAS/TAS	TCAS II	Not fitted
Alert	TA	N/A
Separation		
Reported	200ft V 0.25nm H	0ft V/600m H
Recorded	<100ft V/0.2nm H

THE AW189 PILOT reports that he had just completed wet-winch training east of Cardiff airport (south of Lavernock point), and began a visual recovery to St Athan. He remained outside controlled airspace but climbed from 200ft to 600ft to improve comms with Cardiff. The RT was very busy with IFR and VFR traffic in the vicinity of Cardiff, and multiple TCAS contacts. On reaching about 600ft, a TCAS aural and visual caution activated. Initially the pilot noted a TCAS contact in the 11 o'clock; however, the winchman called visual with a fixed-wing aircraft at 4 o'clock and turning away. The RHS pilot saw a white DA42 and estimated it was 200ft above and within 0.25nm. Neither pilot remembered Traffic Information being passed by Cardiff. No avoiding action was necessary.

THE DA42 PILOT reports that he was in receipt of a radar service from Cardiff, prior to a zone transit along the coast to land at St Athan. He was holding at Lavernock point, as directed by Cardiff. A helicopter made contact with Cardiff on the radio and, shortly afterwards, he was aware of a helicopter to the south-east. He continued to circle while the helicopter passed by. A colleague in a following aircraft holding behind was forced to move his holding circle to the north in order to maintain a reasonable separation from the helicopter because it was flying unpredictably. There was no risk of collision but the helicopter pilot attempted to fly through the area where they had been directed to hold by Cardiff. It appeared that he joined the frequency only a short time before arriving in the area. He noted that the cloud base was around 1000ft and the visibility was approximately 5-7km; both fixed-wing aircraft were white and this may have made it difficult for the helicopter pilot to see them.
