AIRPROX REPORT No 2017001

Date: 05 Jan 2017 Time: 1512Z Position: 5307N 00038W Location: SW Waddington

PART A: SUMMARY OF INFORMATION REPORTED TO UKAB

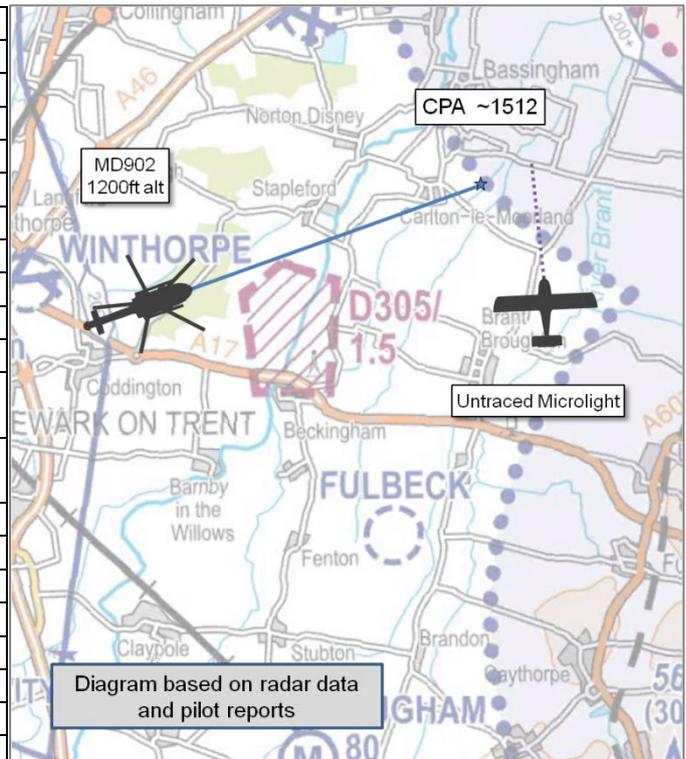
THE MD902 PILOT reports that he was transiting back to RAF Waddington, as they approached Newark they contacted Waddington Zone for a Basic Service. Waddington gave warning of traffic in the 1 o'clock position with no transponder information. Then a second aircraft was called to the left and above. Whilst looking out for both reported aircraft, a high-wing, light-aircraft with fixed undercarriage was seen directly ahead in the 12 o'clock position at a range of about 0.25nm, moving slowly from right to left. He took avoiding action by turning right.

He assessed the risk of collision as 'Medium'.
