**AIRPROX REPORT No 2017032**

Date: 16 Feb 2017 Time: 0934Z Position: 5055N 00120W Location: SAM hold

**PART A: SUMMARY OF INFORMATION REPORTED TO UKAB**

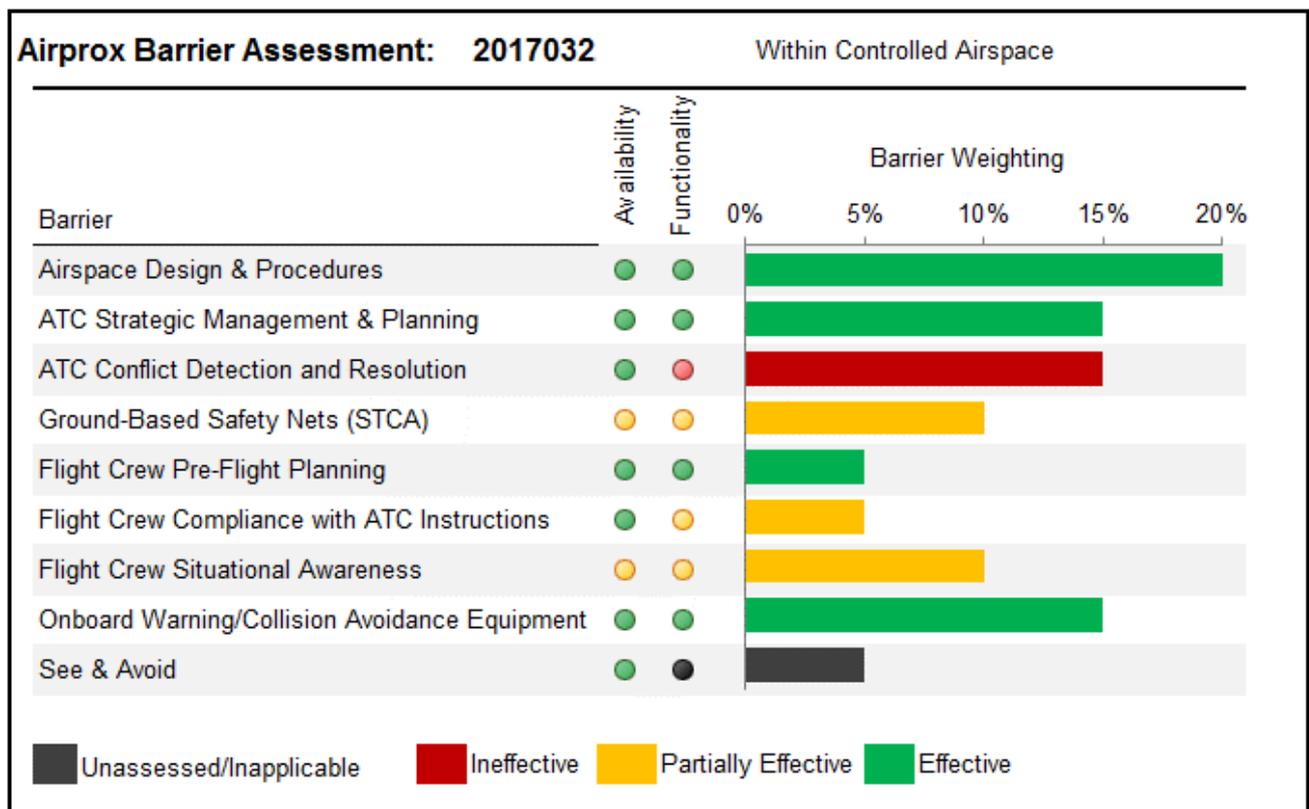
<u>Cause:</u>	The Solent Radar controller cleared the DHC8 pilot to descend without confirming that the D228 pilot had left 5000ft.
<u>Contributory Factor:</u>	1) The D228 pilot descended at a much shallower than expected rate of descent without informing ATC. 2) The Southampton STCA did not trigger.
<u>Degree of Risk:</u>	C.

**Flight crew compliance with ATC instructions** was assessed as **partially effective** because the D228 pilot selected an unusually low rate of descent when cleared to descend by ATC.

**Flight Crew Situational Awareness** was assessed as **partially effective** because only the DHC8 pilot was aware of the presence of the D228, having observed it on his TCAS display. Although both pilots were on the same frequency in the SAM holding pattern, the D228 pilot did not detect that the DHC8 pilot had been descended to his altitude.
