AIRPROX REPORT No 2017038

Date: 08 Mar 2017 Time: 1201Z Position: 5310N 00236W Location: Oulton Park VRP

PART A: SUMMARY OF INFORMATION REPORTED TO UKAB

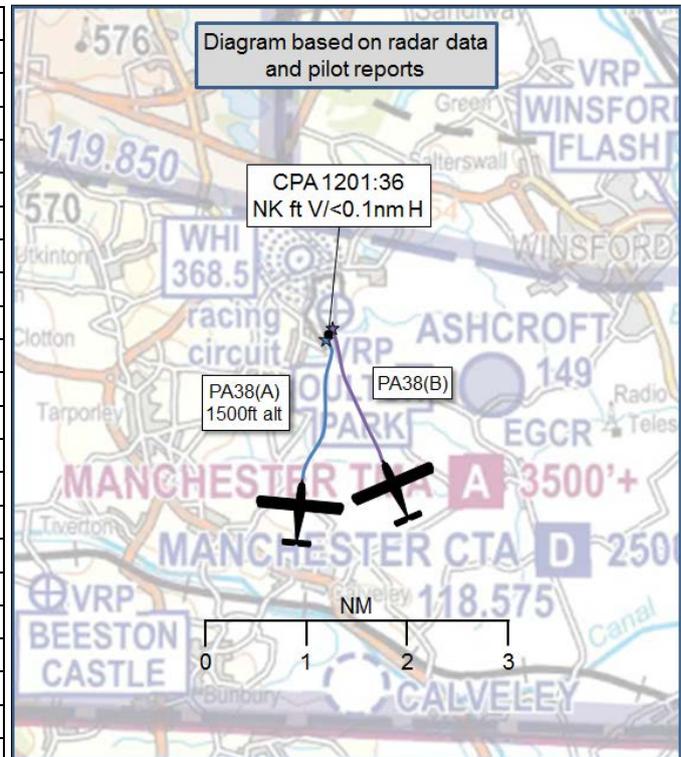
Recorded	Aircraft 1	Aircraft 2
Aircraft	PA38(A)	PA38(B)
Operator	Civ Trg	Civ Trg
Airspace	London FIR	London FIR
Class	G	G
Rules	VFR	VFR
Service	Basic	Basic
Provider	Liverpool	Liverpool
Altitude/FL	1500ft	NK
Transponder	On/C, S	On
Reported		
Colours	White	White, Blue
Lighting	Not reported	Anti-Col
Conditions	VMC	VMC
Visibility	10km	>10km
Altitude/FL	1400ft	1500ft
Altimeter	QNH (1011hPa)	QNH (1011hPa)
Heading	350°	360°
Speed	90kt	90kt
ACAS/TAS	Not fitted	Not fitted
Separation		
Reported	0ft V/10m H	Not seen
Recorded	NK V/<0.1nm H

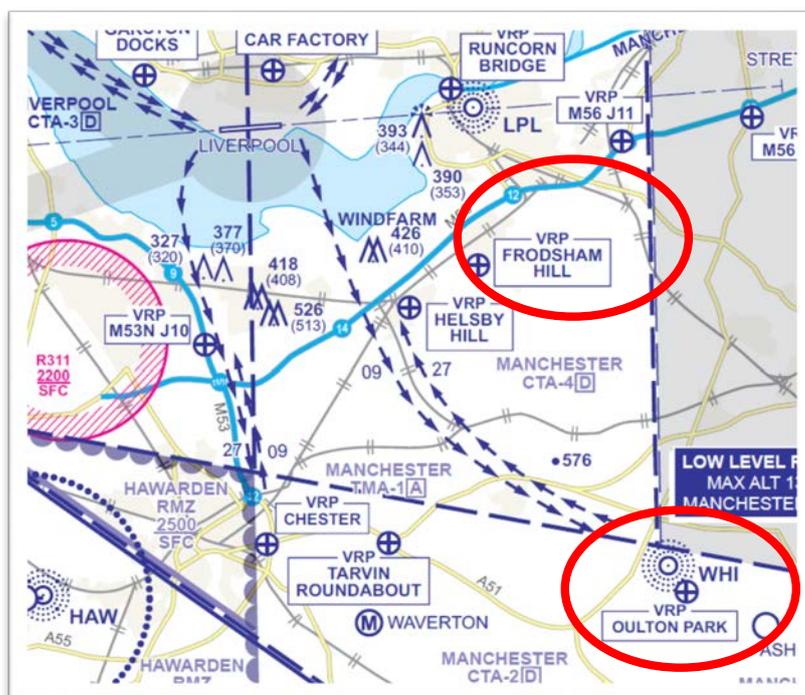
Figure 1 – Liverpool Control Area (CTA)

At 1158:31, the PA38(A) pilot called Liverpool Radar to request re-join at Oulton Park VRP. Liverpool Radar cleared the PA38(A) pilot to join controlled airspace via Oulton Park not above 1500ft and route to Frodsham Hill. The clearance was readback correctly by the pilot. Figure 1 highlights Oulton Park and Frodsham Hill.
