**AIRPROX REPORT No 2017047**

Date: 02 Apr 2017 Time: 1358Z Position: 5231N 00215W Location: Halfpenny Green (elev 283ft)

**PART A: SUMMARY OF INFORMATION REPORTED TO UKAB**

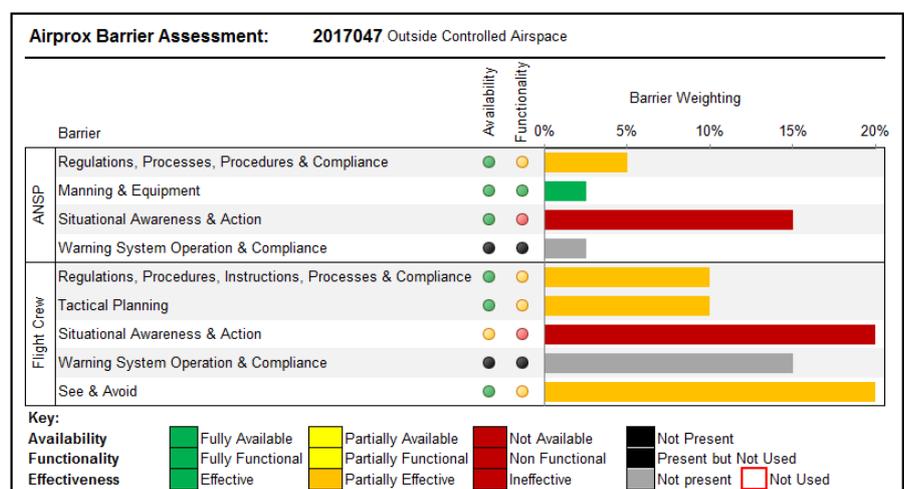
**Situational Awareness and Action** were assessed as **ineffective** because the PA38 pilot had information that the DA40 was getting airborne but did not integrate with it.

**See and Avoid** were assessed as **partially effective** because neither pilot saw the other aircraft until a late stage.
