AIRPROX REPORT No 2017132

Date: 14 Jun 2017 Time: 1513Z Position: 5101N 00251W Location: Curry Rivel

PART A: SUMMARY OF INFORMATION REPORTED TO UKAB

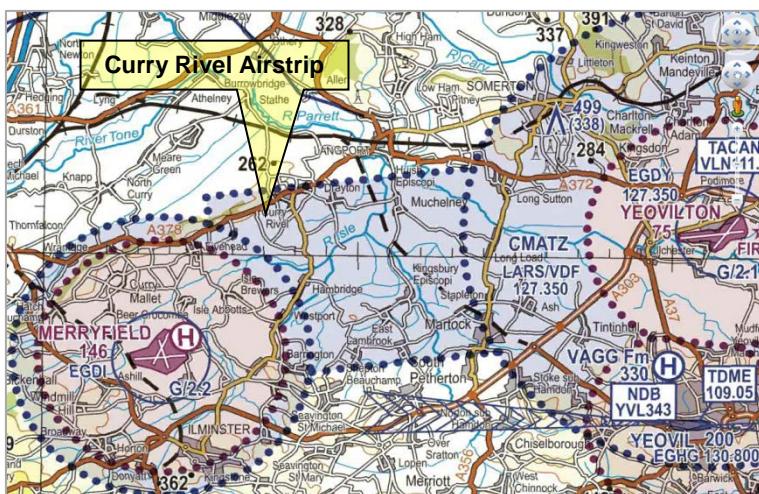
The Wildcat and TB10 pilots shared an equal responsibility for collision avoidance and not to operate in such proximity to other aircraft as to create a collision hazard¹. If the incident geometry is considered as converging then the Wildcat pilot was required to give way to the TB10². An aircraft operated on or in the vicinity of an aerodrome shall conform with or avoid the pattern of traffic formed by other aircraft in operation³.
