## AIRPROX REPORT No 2017165

Date: 19 Jul 2017 Time: 0945Z Position: 5210N 00007E Location: 3nm SW Cambridge Airport

### PART A: SUMMARY OF INFORMATION REPORTED TO UKAB

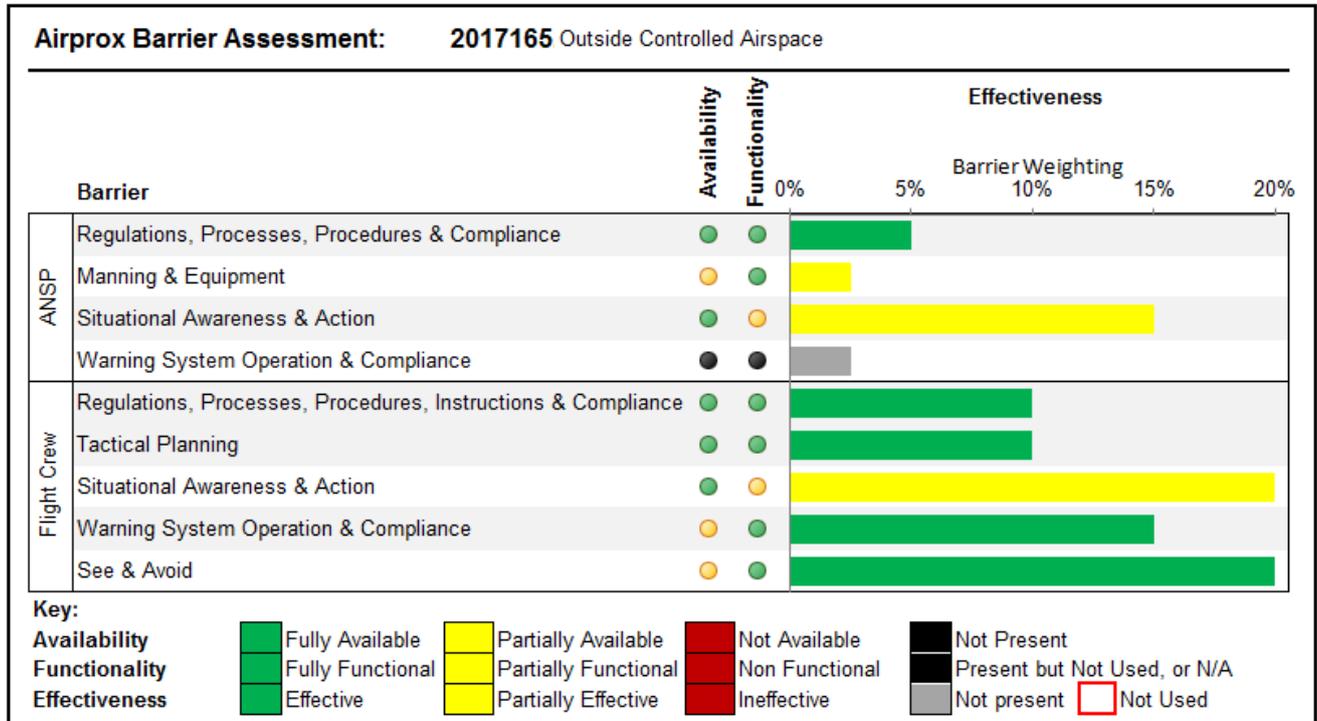
**Situational Awareness & Action** was assessed as **partially effective** because both the AC114 pilot and the DH89 pilot had sufficient Traffic Information on each other but were not proactive enough in resolving the conflict early.
