## AIRPROX REPORT No 2017260

Date: 01 Nov 2017 Time: 1529Z Position: 5355N 00114W Location: 2nm SW Rufforth Glider Site

### PART A: SUMMARY OF INFORMATION REPORTED TO UKAB

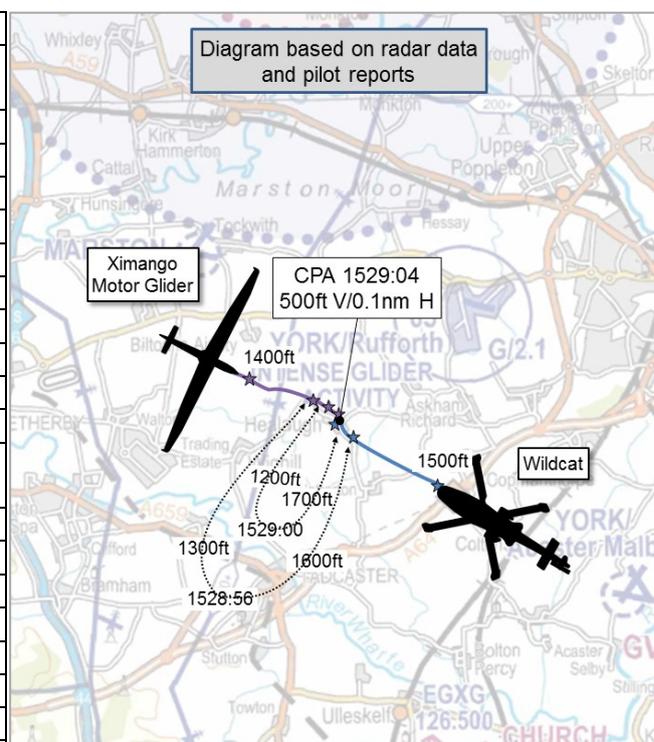
Recorded	Aircraft 1	Aircraft 2
Aircraft	Wildcat	Ximango Motor Glider
Operator	HQ JHC	Civ Club
Airspace	London FIR	London FIR
Class	G	G
Rules	VFR	VFR
Service	Traffic	AGCS
Provider	Linton Zone	Rufforth
Altitude/FL	1700ft	1200ft
Transponder	A, C, S	A, C
<b>Reported</b>		
Colours	Grey	White
Lighting	Landing, Strobe, Nav	Strobe
Conditions	VMC	VMC
Visibility	>10km	>10km
Altitude/FL	1700ft	2000ft
Altimeter	RPS (1012hPa)	Rufforth QFE
Heading	280°	180°
Speed	120kt	60kt
ACAS/TAS	TAS	Not fitted
Alert	Unserviceable	N/A
<b>Separation</b>		
Reported	250m	NK
Recorded	500ft V/0.1nm H
