## AIRPROX REPORT No 2017002

Date: 05 Jan 2017 Time: 1409Z Position: 5321N 00058E Location: AARA8<sup>1</sup>

### PART A: SUMMARY OF INFORMATION REPORTED TO UKAB

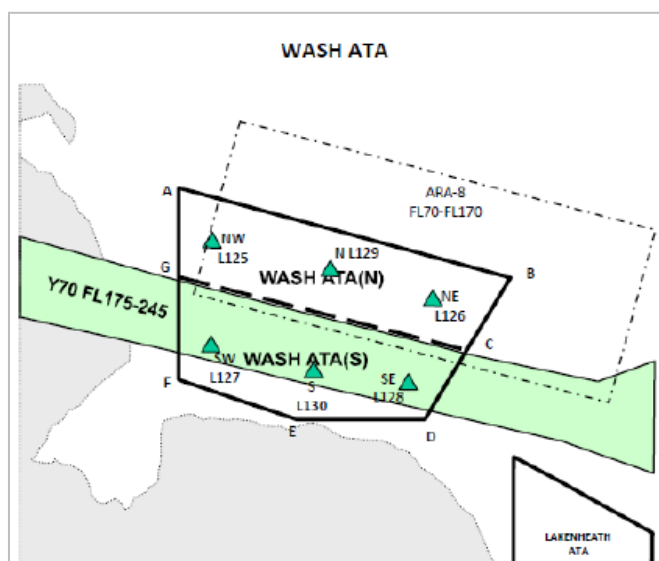
Figure 9: AARA8 and Wash ATA

(ATA), which has defined parameters and can be displayed on the radar map. The Swanwick E Tac R controller did not clarify the location and was subsequently found not to be aware of the geographical location of the Wash ATA, therefore assumed that the F15s would remain to the south of AARA 8 and did not pass information on its activity.

For their part, the Board commented that the Voyager crew's report inferred that they were not expecting non-refuelling traffic to be in their 'allocated' operational area and flight levels. Whilst acknowledging the geographical delineation of AARAs for integration purposes, members stressed that the activity was being carried out in Class G airspace, and that aircraft were therefore entitled to fly through the towline on a see-and-avoid basis. Some members wondered whether, given the potential lack of manoeuvrability of tanker towline operations, there was a case for them being afforded more protection through segregation or formal NOTAM action. A military member from the HQ Air Command Safety Centre commented that after the incident there had been a discussion about refuelling areas being classified as segregated airspace. However, the risks associated with conducting operations of this nature in Class G airspace had been assessed as being acceptable based on the requirements of other, non-military, airspace users. He acknowledged that the Wash ATA and AARA8 are within overlapping areas but, given that both were under the control of Swanwick, this was not identified as a causal factor within the military incident investigation.

adopted) to review airspace names to prevent confusion in the future. Recommendations were also made for Swanwick to review their console management with respect to telephone call management.

The Board were heartened that the military had conducted a thorough incident investigation in conjunction with USAFE, and that they had recommended changes and enhancements to the current systems to prevent a reoccurrence of this Airprox, including a review of the naming of the Wash ATA areas to avoid future confusion.
