AIRPROX REPORT No 2017003

Date: 05 Jan 2017 Time: 1542Z Position: 5154N 00118W Location: 3.5nm NE Oxford airport

PART A: SUMMARY OF INFORMATION REPORTED TO UKAB

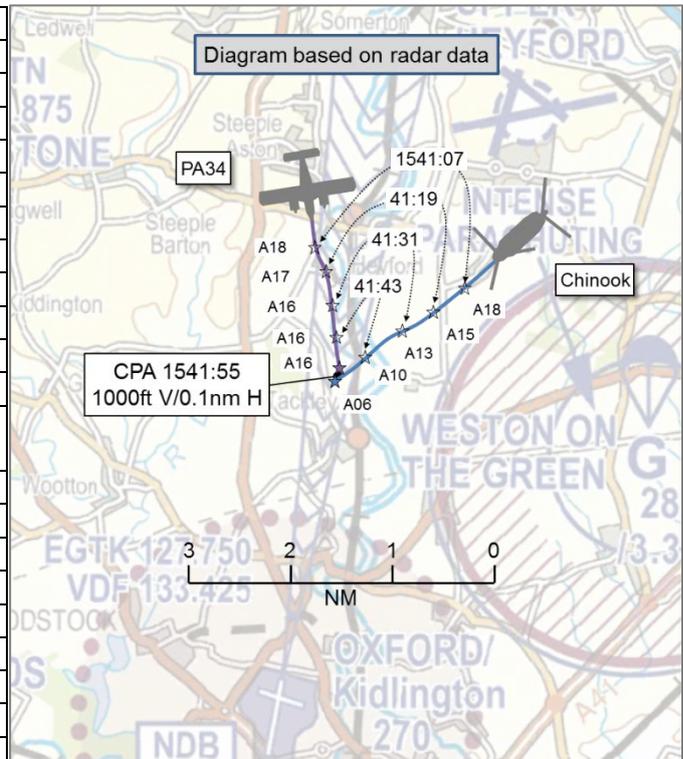
Recorded	Aircraft 1	Aircraft 2
Aircraft	PA34	Chinook
Operator	Civ Trg	HQ JHC
Airspace	London FIR	London FIR
Class	G	G
Rules	IFR	VFR
Service	Aerodrome	Basic
Provider	Oxford	Brize
Altitude/FL	1500ft	700ft
Transponder	A,C,S	A,C,S
Reported		
Colours	White, blue	Green
Lighting	Strobes, landing, nav	White HISL, nav (bright)
Conditions	VMC	VMC
Visibility	10km	3.5km Haze
Altitude/FL	1500ft	700ft
Altimeter	QNH (1034hPa)	QNH
Heading	193°	235°
Speed	100kkt	NK
ACAS/TAS	TAS	TAS
Alert	None	TA
Separation		
Reported	100-200ft V/0m H	500ft V/0m H
Recorded	1000ft V/0.1nm H
