AIRPROX REPORT No 2017040

Date: 16 Mar 2017 Time: 1259Z Position: 5325N 00018W Location: 9nm south Humberside

PART A: SUMMARY OF INFORMATION REPORTED TO UKAB

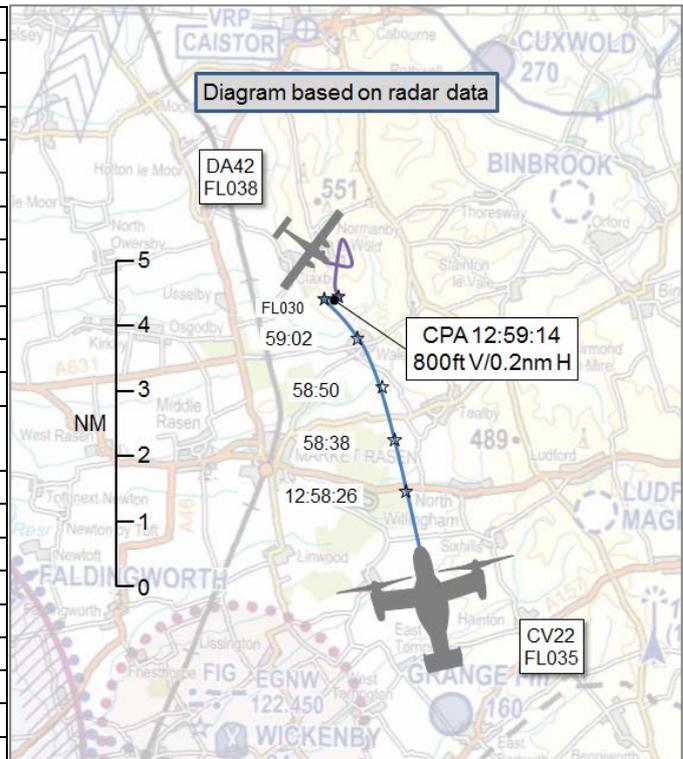
Recorded	Aircraft 1	Aircraft 2
Aircraft	CV22	DA42
Operator	Foreign Mil	Civ Trg
Airspace	London FIR	London FIR
Class	G	G
Rules	VFR	VFR
Service	Traffic	Traffic
Provider	Coningsby	Humberside
Altitude/FL	FL030	FL038
Transponder	A, C, S	A, C, S
Reported		
Colours	Grey	White
Lighting	Strobes, nav	Strobes, nav, landing, taxi
Conditions	VMC	VMC
Visibility	20nm	>15km
Altitude/FL	FL035	3900ft
Altimeter	1013hPa	QNH (1018hPa)
Heading	340°	110°
Speed	225kt	120kt
ACAS/TAS	TCAS I	TCAS I
Alert	TA	None
Separation		
Reported	200ft V/0m H	400ft V/0m H
Recorded	800ft V/0.2nm H
