AIRPROX REPORT No 2017084

Date: 08 May 2017 Time: 1314Z Position: 5119N 00001E Location: Biggin Hill

PART A: SUMMARY OF INFORMATION REPORTED TO UKAB

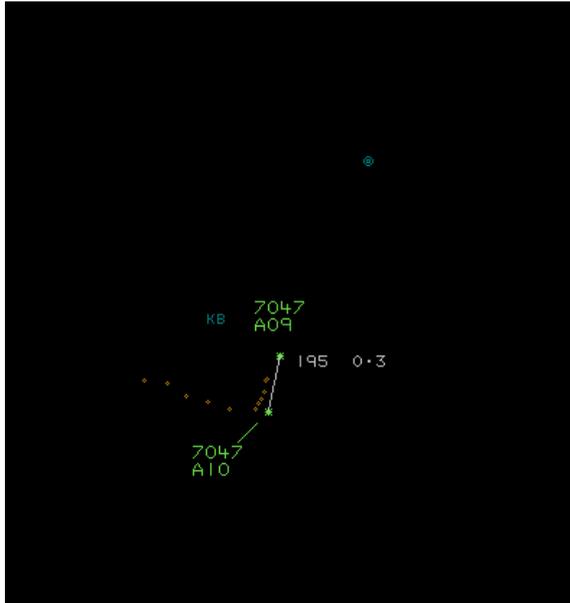
Figure 7 – 1313:54

Figures 7-9 illustrate the situation as it continued to then develop:

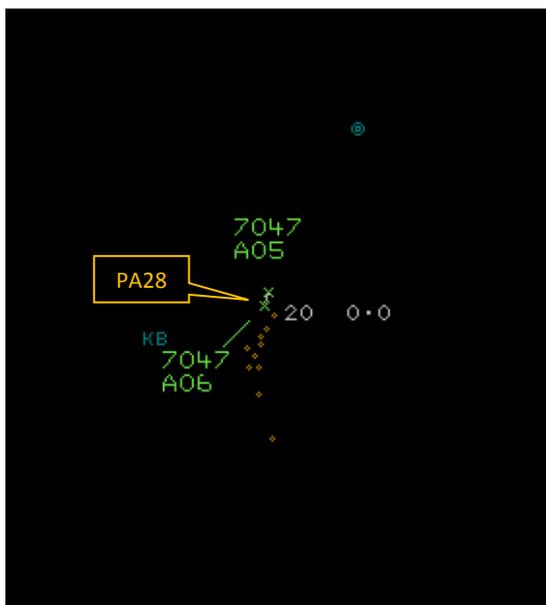
Figure 13 – 1314:23

Figures 13-14 illustrate the situation as it developed further. CPA took place at 1314:48 (Figure 14), with the radar replay showing both aircraft at the same altitude with <math><0.1\text{nm}</math> lateral separation.
