AIRPROX REPORT No 2017106

Date: 02 Jun 2017 Time: 1434Z Position: 5047N 00054W Location: ivo Thorney Island

PART A: SUMMARY OF INFORMATION REPORTED TO UKAB

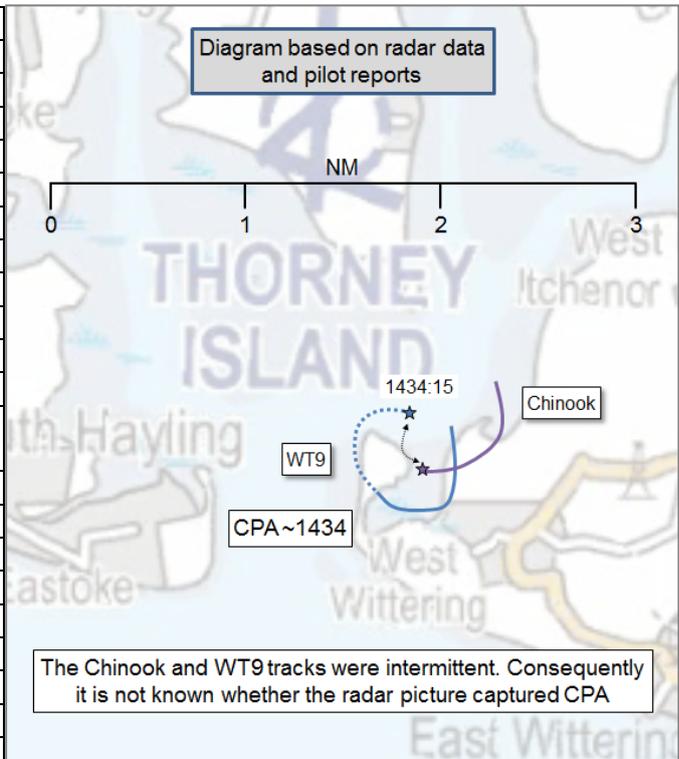
THE CHINOOK PILOT reports conducting an over-water display practice south of Thorney Island. A good lookout was being maintained by the crew of three, in good visibility, backed up by the TAS. In addition, the display supervisor was looking out from Thorney Island and had direct radio communication throughout. During the second full display sequence, the co-pilot noticed an aircraft indication on the TAS, was able to visually identify it, and called for the display practice to be stopped. The next manoeuvre was aborted and the co-pilot guided the handling pilot's eyes towards the other aircraft, in the right 1.30 position, whilst the handling pilot made a climbing left hand turn to deconflict. The other aircraft was a white, T-tailed, single piston-engine civilian aircraft with no obvious markings. At this point, the other aircraft was about 2-3 miles away at 1000ft and was considered not to be a direct threat to safety. However, the display practice was aborted owing to uncertainty as to the other pilot's future intentions. The Chinook pilot climbed to 500ft, started a right hand orbit anchored on Thorney Island and, with Goodwood Information's permission, attempted to raise the pilot of the civilian aircraft. No reply was received. It became apparent that the other aircraft was heading towards them and the Chinook crew maintained visual contact, expecting the aircraft to transit from southeast to northwest, past their location. The Chinook pilot reduced his rate of turn as the other aircraft approached their four o'clock position to assist in achieving greater lateral separation while the civilian aircraft passed them. The crewman then informed the Captain that he perceived that the civilian aircraft appeared to be 'tipping in' on them (turning and descending towards them) and closing range in an attempt to follow or formate. The Chinook Captain increased speed from 80kt to about 130kt whilst maintaining level flight to get away from the civilian aircraft. As the aircraft flew towards the Chinook, the co-pilot selected guard and the Captain made a call on the VHF guard frequency, 'Aircraft in the vicinity of Thorney Island attempting to follow or formate on a Chinook, this is Chinook aircraft [C/S], cease and turn away'. There was no response and the civilian aircraft was perceived to continue to try to follow but was unable to keep up, closing to 200m from the Chinook at its closest point as estimated by the crewman. The civilian aircraft then turned left away and the Display

Authoriser reported that it appeared to him to fly over houses at West Wittering at an estimated 200-300ft agl. It was then witnessed by the Chinook crew to turn out to sea and descend further to 100ft, both visually judged and informed by their TAS reading which showed the aircraft 600ft below them when their altitude was 700ft. The civilian aircraft was then perceived by the Chinook crewman to fly directly past boats at 100ft. Both visual and TAS contact were lost at a range of about 5-7 nm as the aircraft headed away. The Chinook pilot noted that it is a requirement that over-water display training flights are conducted in order to maintain display currency, and that Thorney Island was chosen as a site representative of the considerations that are likely at public displays. As part of the supervisory and crew risk assessments, consideration had been given to the submission of a NOTAM for the display practice but it was decided not to submit a NOTAM for the following reasons:
