**AIRPROX REPORT No 2017114**

Date: 07 Jun 2017 Time: 1551Z Position: 5317N 00432W Location: Valley

**PART A: SUMMARY OF INFORMATION REPORTED TO UKAB**

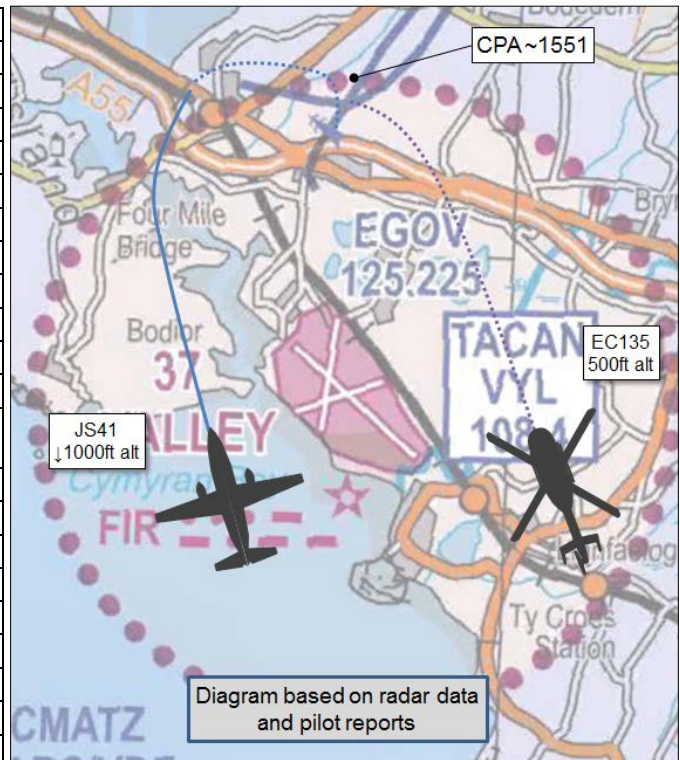
**THE VALLEY SUPERVISOR** reports that during a low-intensity flying period a civilian JS41 was positioned by Valley App for a downwind visual join as an Air Ambulance was approaching the MATZ from the SE to cross the ATZ to attend an incident 7nm N Valley. He went from the ACR to the VCR in time to see the JS41 wide-downwind to RW19, indicating 1000ft on the ATM. At the same time, the Air Ambulance was approaching the airfield boundary from the SE, indicating 700ft. It was immediately evident to him that, from the aircraft positions, the Air Ambulance would be crossing the approach lane at the same time as the JS41 would be on finals. He asked the ADC what his plan was, but the controller was content that he didn't have to do anything because he had given Traffic Information to both pilots. The Supervisor was not happy with this lack of positive control and therefore told the ADC to extend the JS41 downwind until the Air Ambulance had crossed the approach lane. Before the instruction was passed, the JS41 began to turn finals so the supervisor instructed the ADC to send the JS41 around not below 1000ft. Both aircraft appeared visibly to pass very close to each other in the approach lane, with the Air Ambulance slightly below.
