**AIRPROX REPORT No 2017117**

Date: 14 Jun 2017 Time: 0825Z Position: 5802N 00247W Location: 27nm SE Wick

**PART A: SUMMARY OF INFORMATION REPORTED TO UKAB**

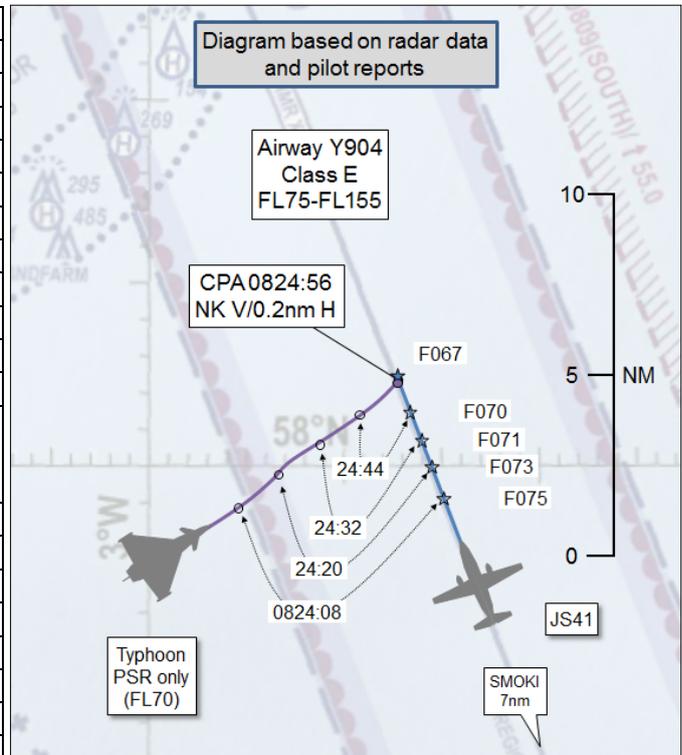
Recorded	Aircraft 1	Aircraft 2
Aircraft	JS41	Typhoon
Operator	CAT	HQ Air (Ops)
Airspace	Scottish FIR	Scottish FIR
Class	G	G
Rules	IFR	VFR
Service	None	Traffic
Provider	(Scottish)	Swanwick Mil
Altitude/FL	FL67	No Mode C/S
Transponder	A,C,S	Unserviceable
Reported		
Colours	Company	Grey
Lighting	Strobes, conspicuity, beacon, nav	Strobes, nav
Conditions	VMC	VMC
Visibility	45km	50km
Altitude/FL	FL78	FL70
Heading	340°	070°
Speed	230kt	350kt
ACAS/TAS	TCAS II	Not fitted
Alert	None	N/A
Separation		
Reported	~250ft V/NK H	Not seen
Recorded	NK V/0.2nm H

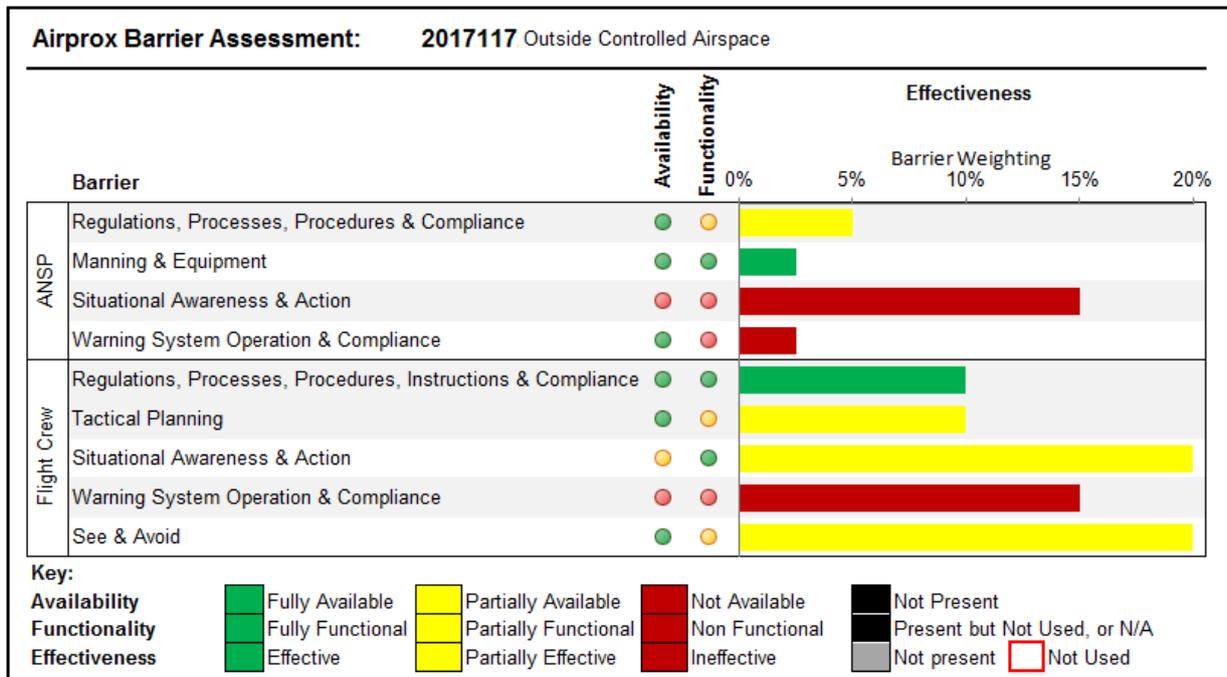
<sup>3</sup> The UK Airprox Board scheme for assessing the Availability, Functionality and Effectiveness of safety barriers can be found on the [UKAB Website](#).

**Warning System Operation and Compliance** were assessed as **ineffective** because the Typhoon was not transponding.

**See and Avoid** was **partially effective** because the JS41 pilot obtained only a late sighting of the Typhoon and was able to take emergency avoiding action; but the Typhoon pilot did not observe the JS41 at all.
