AIRPROX REPORT No 2017159

Date: 12 Jul 2017 Time: 1344Z Position: 5352N 00012W Location: Vale of York

PART A: SUMMARY OF INFORMATION REPORTED TO UKAB

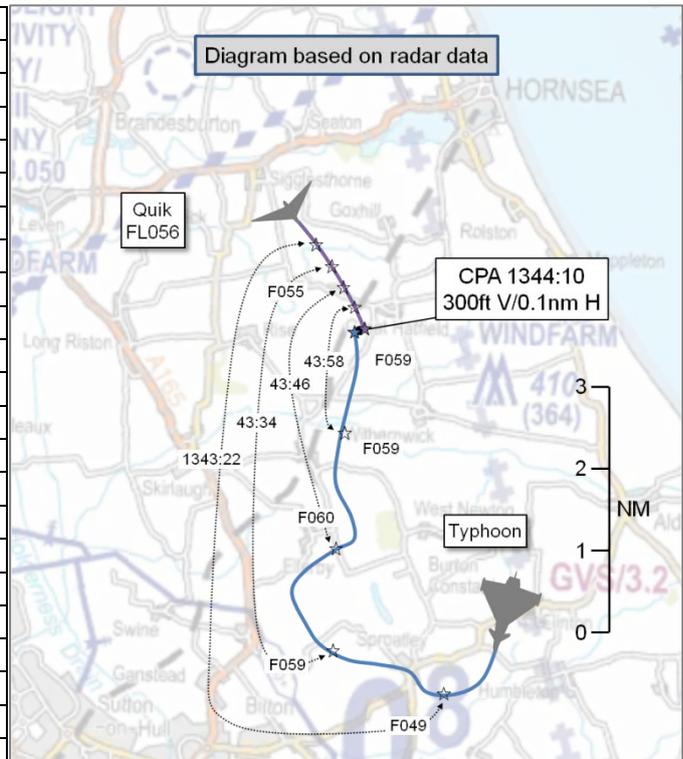
THE TYPHOON PILOT reports conducting a medium-level General Handling (GH) sortie in the southern portion of the Vale of York. He was informed at 1338:35 of a contact 4nm north of his position, manoeuvring at 5000ft. In response to the information call from Swanwick, he deconflicted to the south. After a further 5mins of GH, he proceeded back to the north at 6000ft. At 1344:06, he visually acquired a high-wing light-aircraft, assessed as a microlight, believed to be the traffic initially called approximately 700ft low but within the HUD field of view. A climbing left-hand turn was initiated to increase the miss distance which was assessed to be approximately 2500ft.

THE QUIK PILOT reports that he was in level flight and noticed the Typhoon approaching on a path that looked like it would take it over the top on the right-hand side. The speed of approach was such that from first seeing it to it passing down the right-hand side above was only 7secs. He considered turning right to avoid the approaching aircraft; however, the Typhoon was slightly to the right, he didn't wish to turn into it, and the separation was such that no avoiding action was required. The Typhoon rolled to its left as it approached (turning further to the Quik pilot's right) and passed above and down the right-hand side. The Quik pilot stated that he had assumed that given he had a Mode S transponder and strobes, the Typhoon pilot had seen him and was using him as a ‘dummy target’ [UKAB Note: this was not the case, the encounter was purely circumstantial].
