AIRPROX REPORT No 2017198

Date: 04 Aug 2017 Time: 1412Z Position: 5106N 00148W Location: Overhead Old Sarum aerodrome

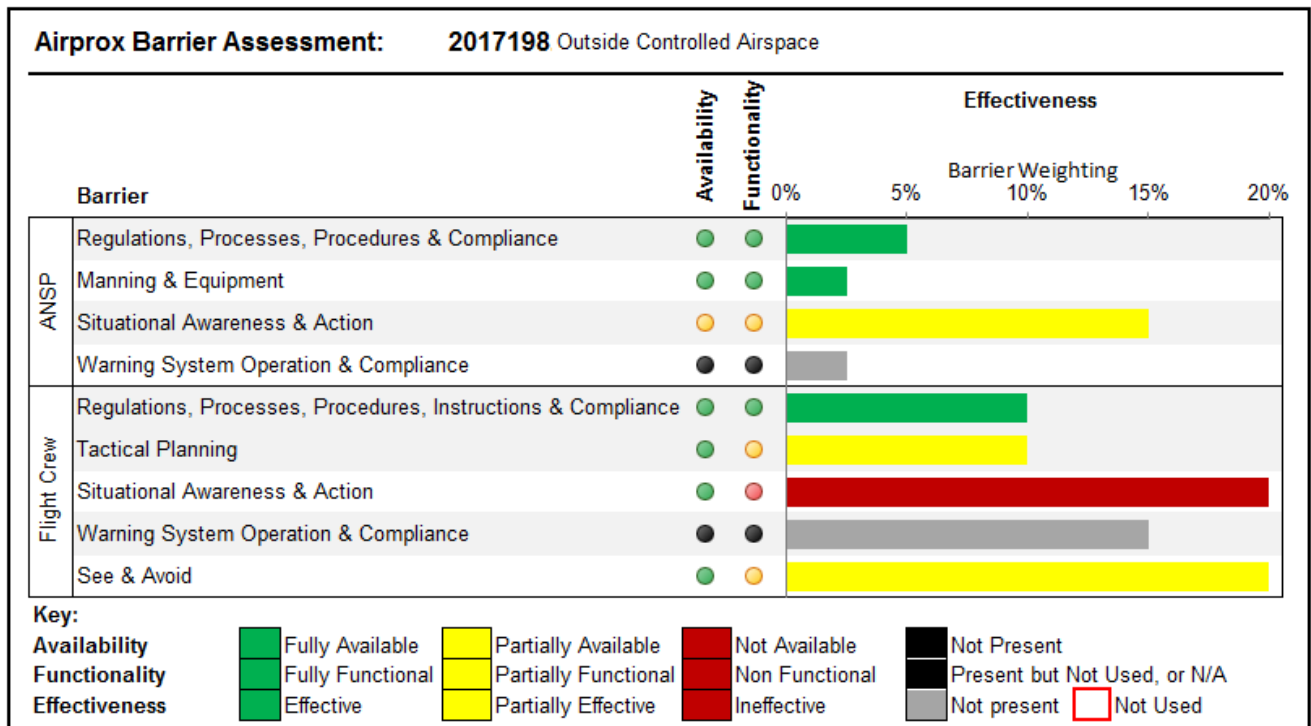
Situational Awareness and Action were assessed as **ineffective** because the Hawk crew did not assimilate the proximity of the C208 and hence did not take action on the basis of the Traffic Information passed to them.

See and Avoid were assessed as **partially effective** because the Hawk crew did not see the C208 and the C208 pilot saw the Hawk at a very late stage, when his options for avoiding action were limited, given the closing speed of the Hawk.
